**TOWNSHIP OF LEEDS AND THE THOUSAND ISLANDS**

**Escott Waste Disposal Site  
2016 Annual Monitoring, Development and  
Operations Report**

## **Executive Summary for Escott WDS (Project #1038)**

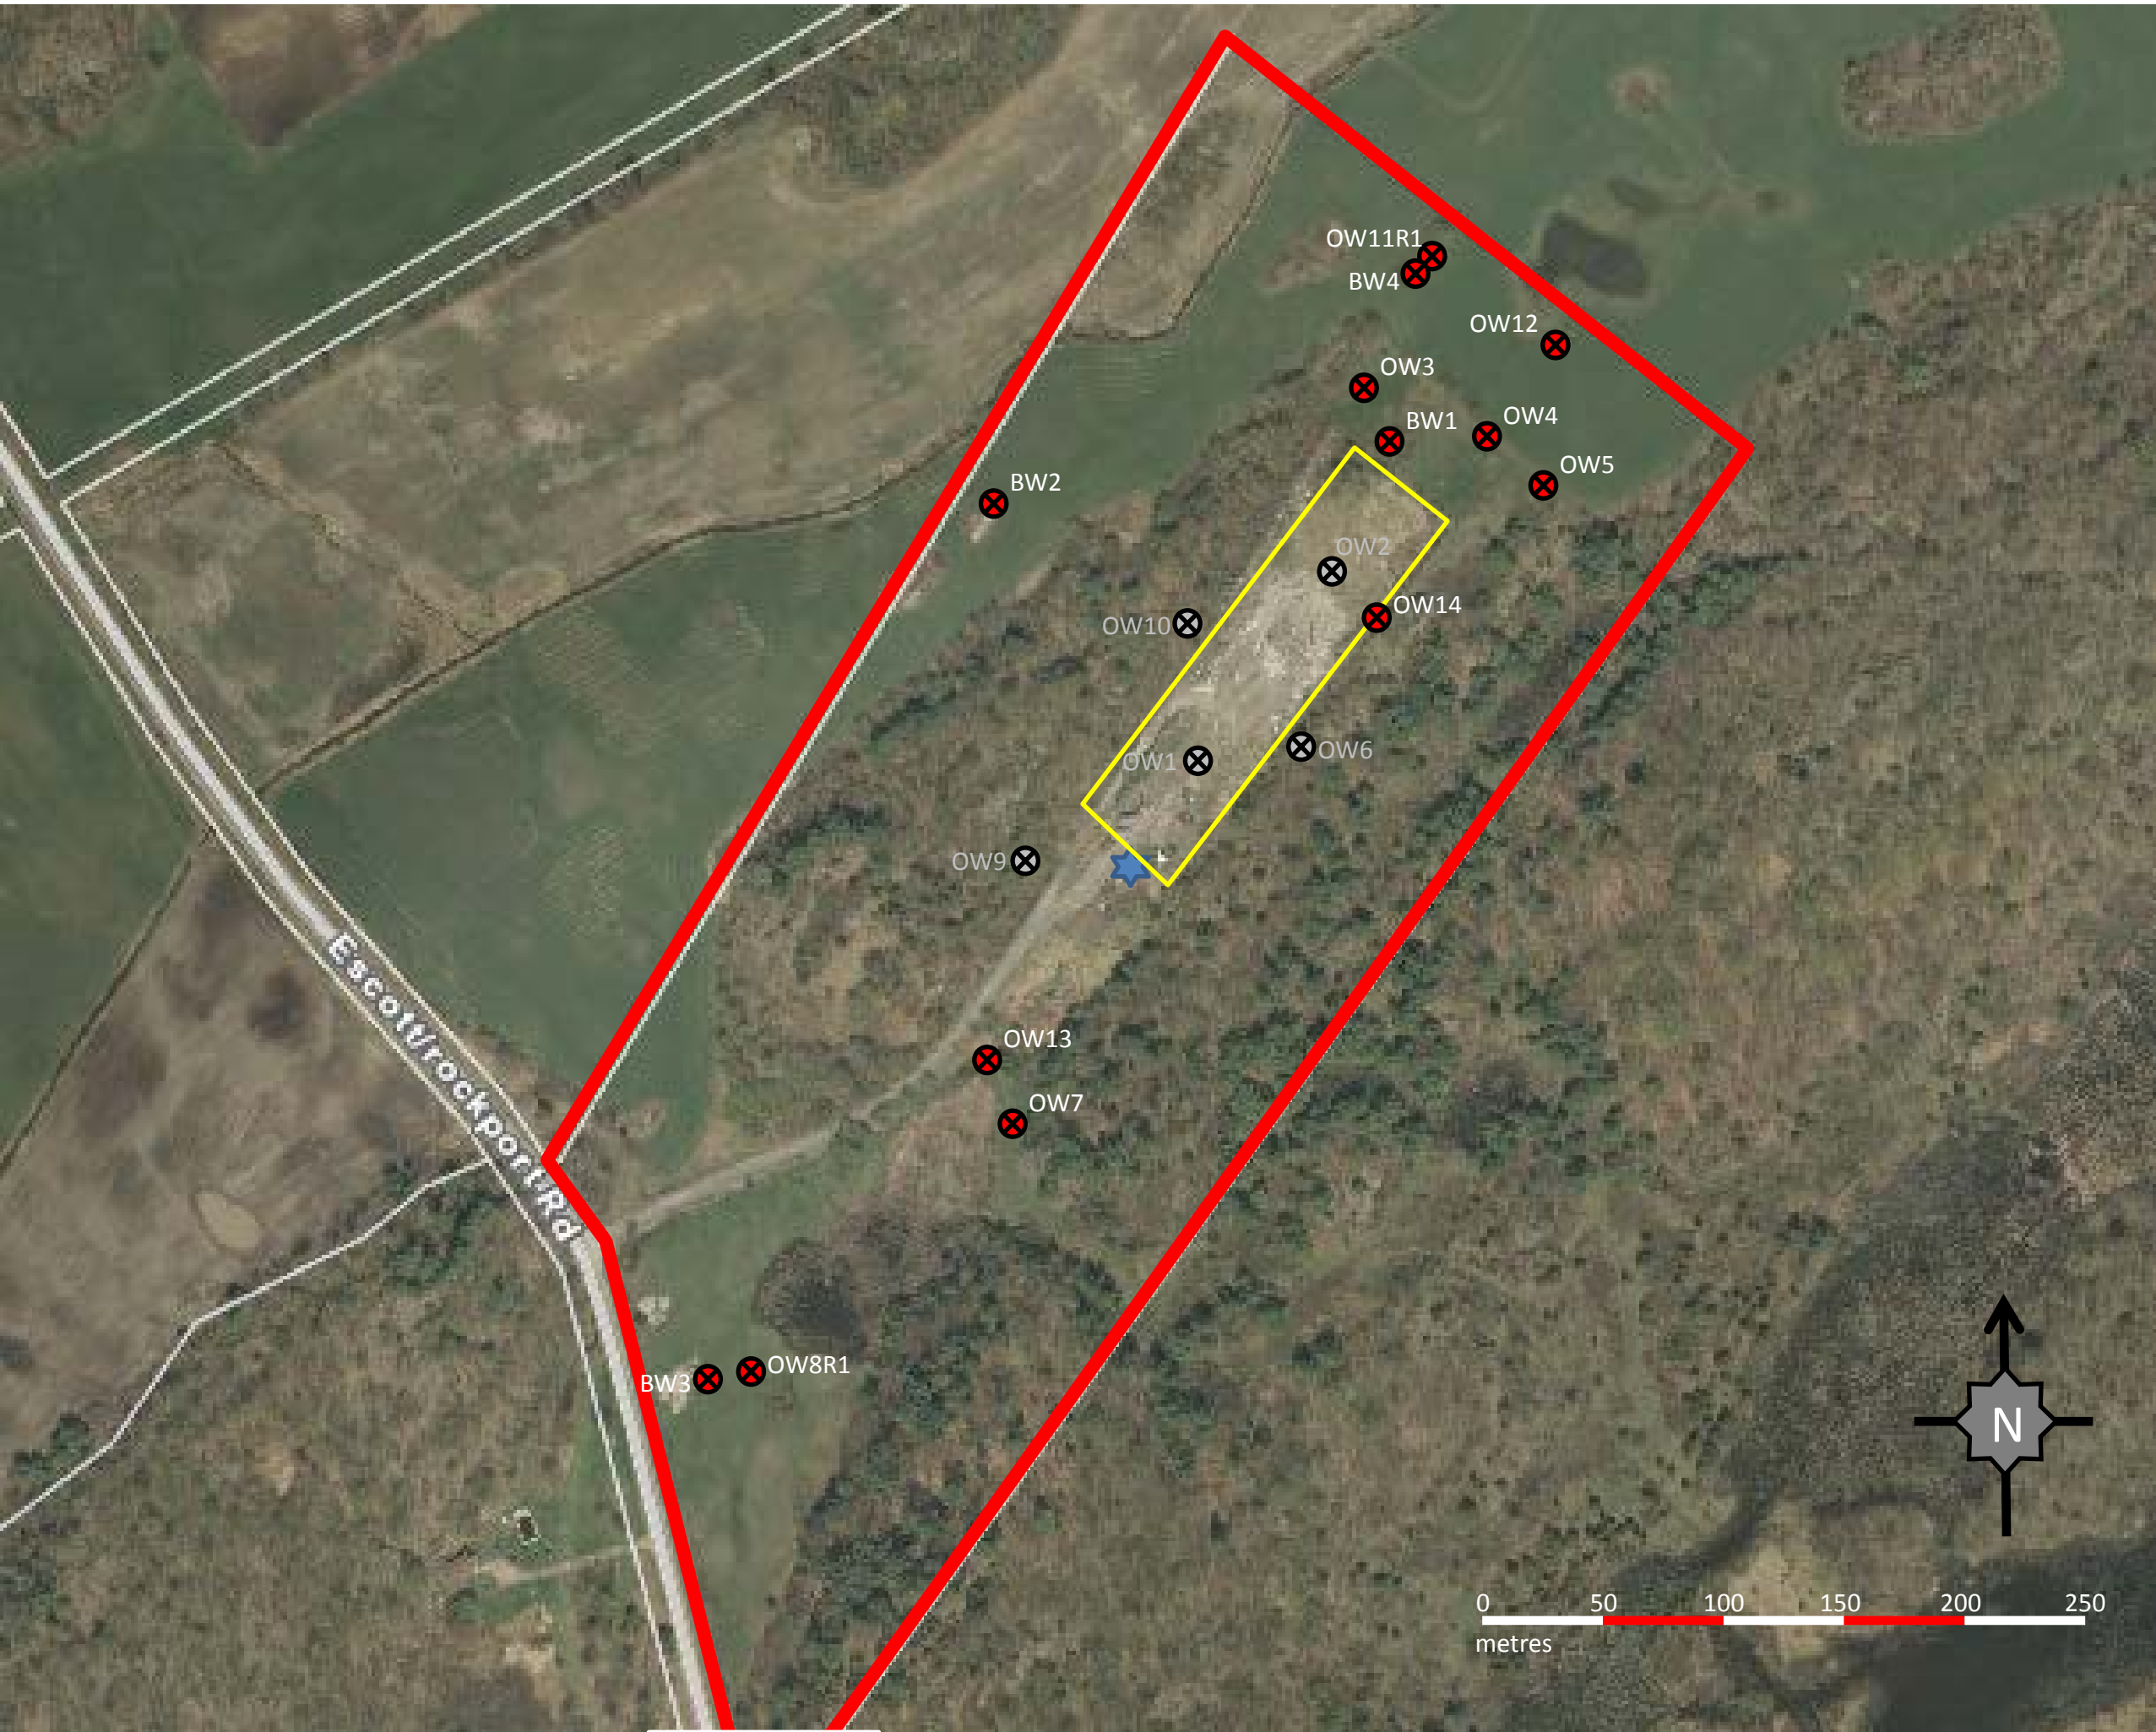
The Site is operated under CofA No. A441703 which permits a 1.0 hectare landfilling Site within a 15.1 hectare property. The Site has an approved waste volume of 40,000 m<sup>3</sup> and is actively landfilling non-hazardous waste materials from within the TLTI. Agricultural and residential land are proximal to the Site. The current Site property boundary and fill area is shown on Figure 2 (Appendix A).

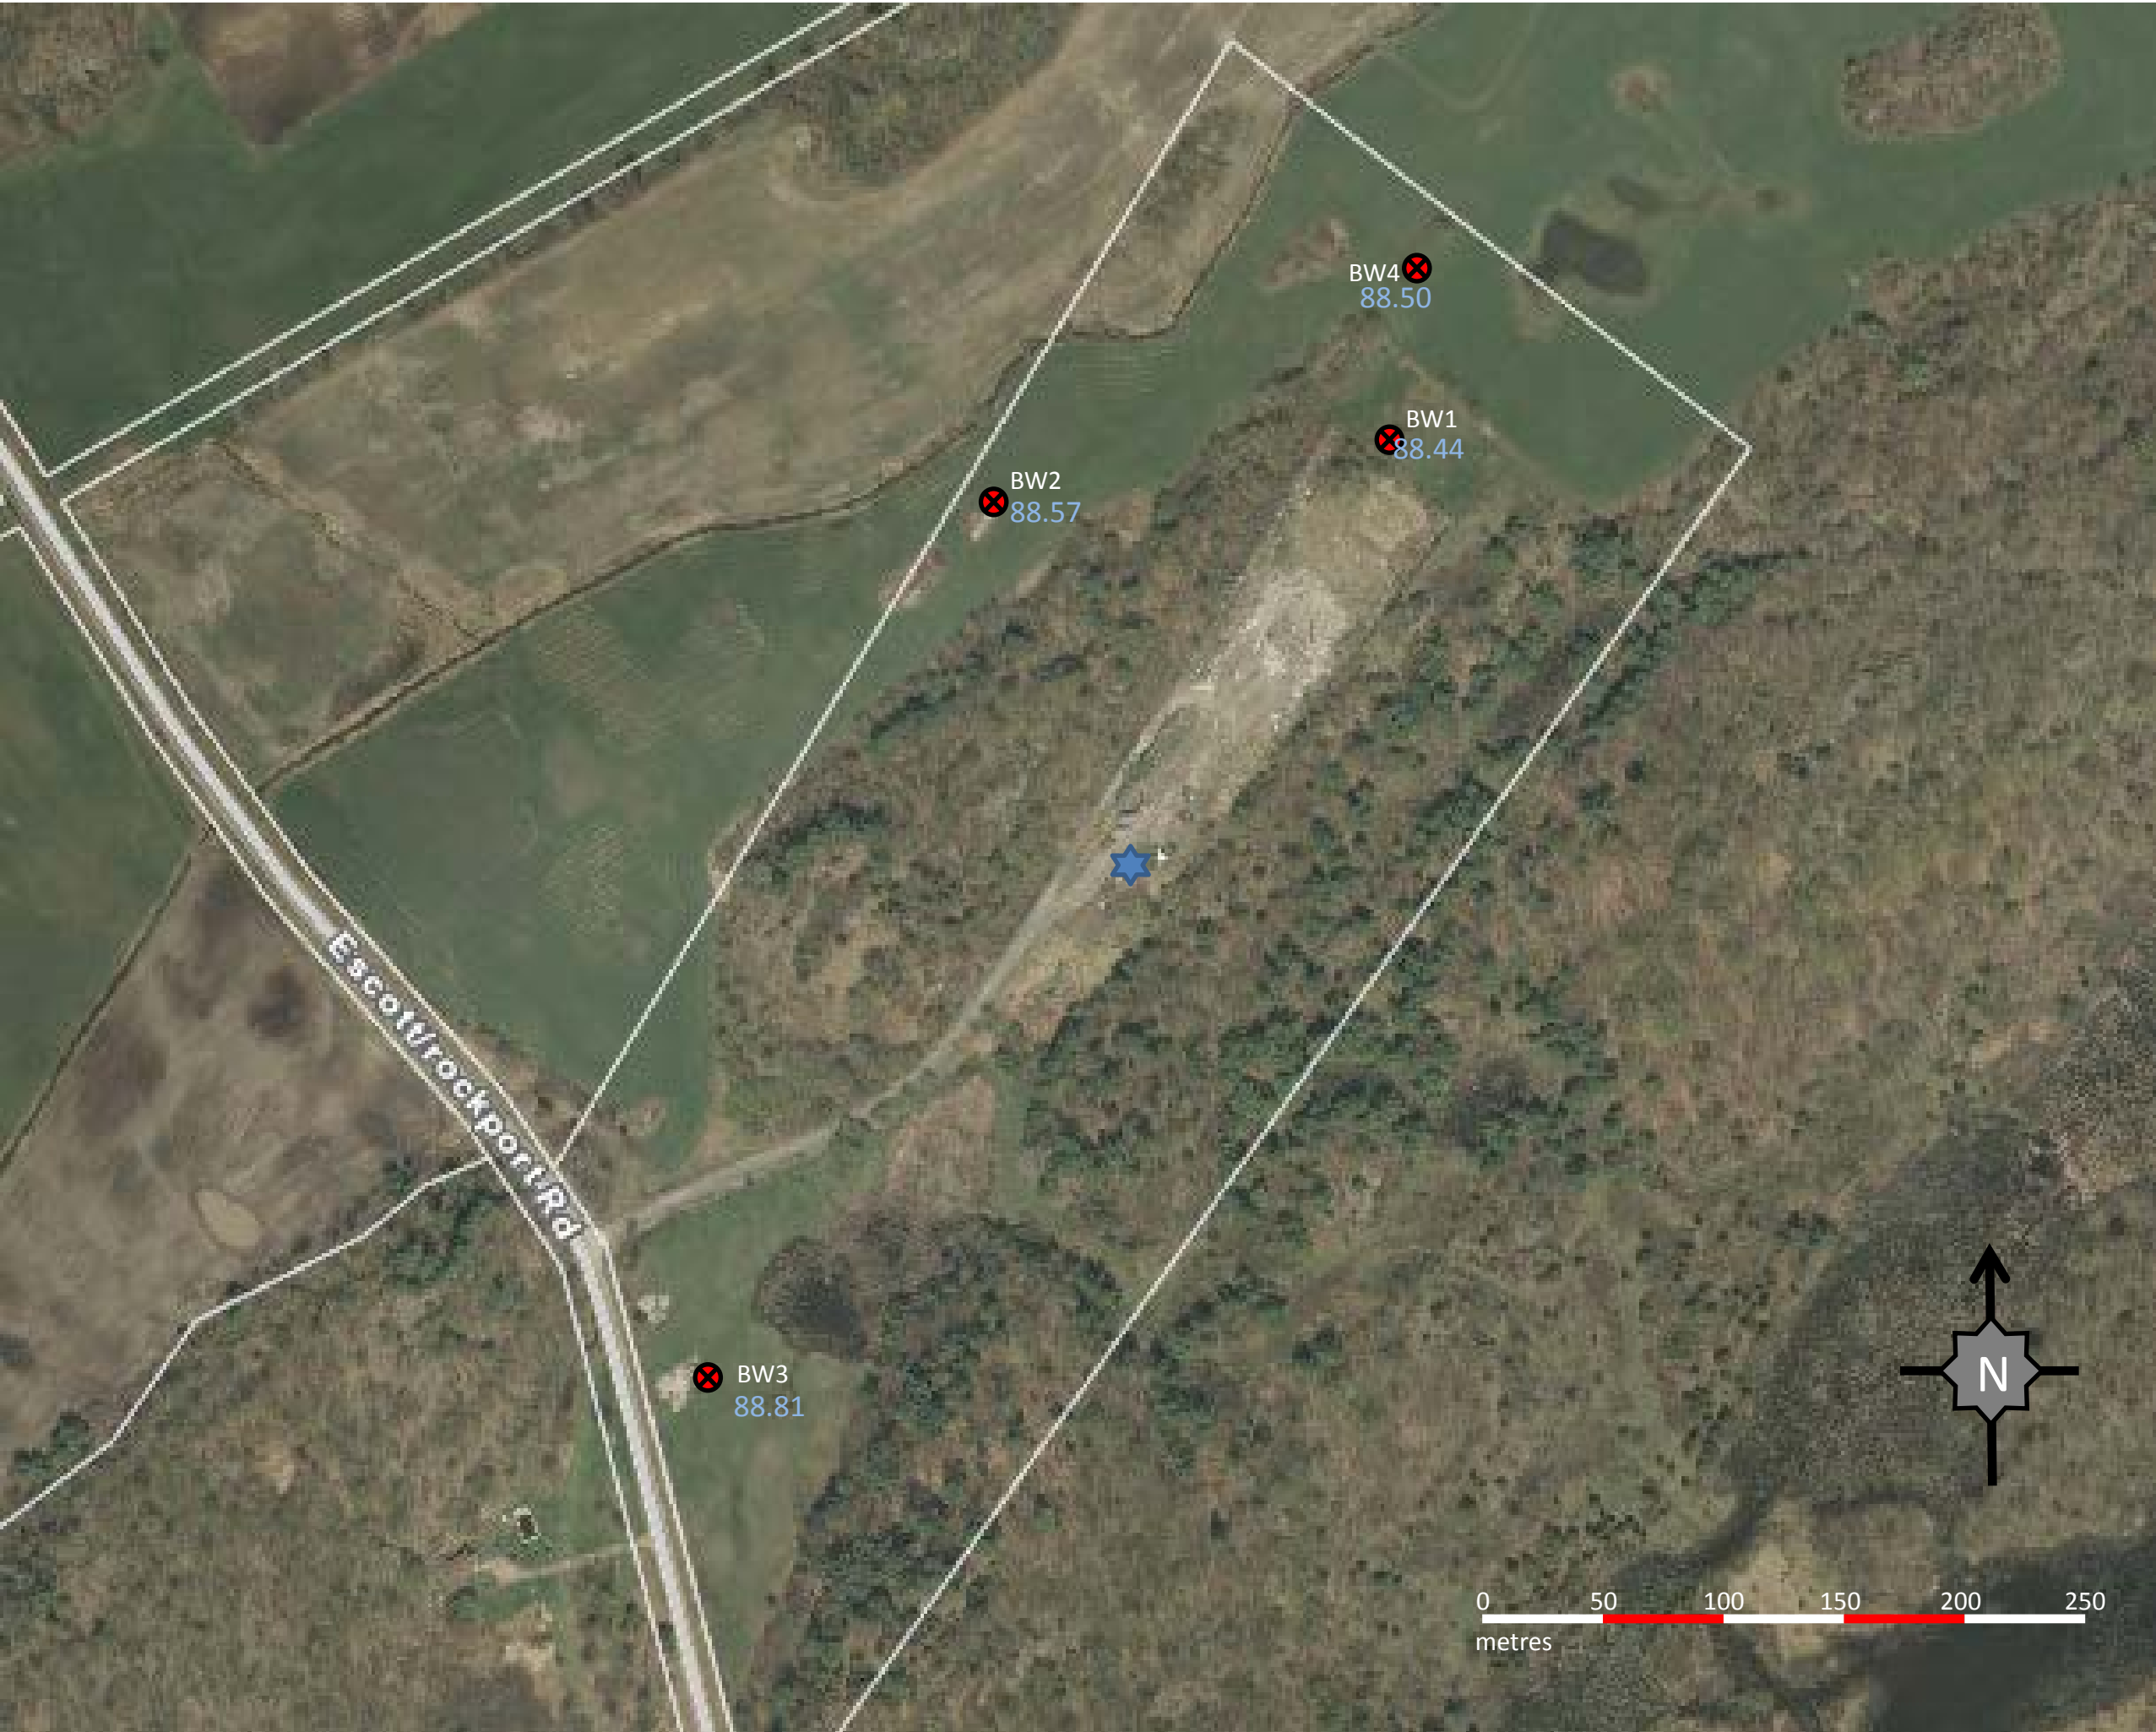
Groundwater contours were also drawn based on the 2015 bedrock water elevation data and presented in Figure 7 (Appendix A). Based on these contours, bedrock groundwater is interpreted to flow towards the northeast. It should be noted, however, that overall elevation differences are no greater than 0.4 m and so are especially sensitive to changes in recharge and discharge.

The bedrock water chemistry at the Site is characterized by four wells: BW1, BW2, BW3 and BW4. Well BW3 is used to characterize the background chemistry as it is located up-gradient from the waste disposal site (Figure 7, Appendix A). Historically, the background chemistry has shown elevated hardness and turbidity. Turbidity measurements were not available for 2016 at the time of reporting. The well's history of high turbidity should be noted as it may influence parameters such as TSS and DOC.

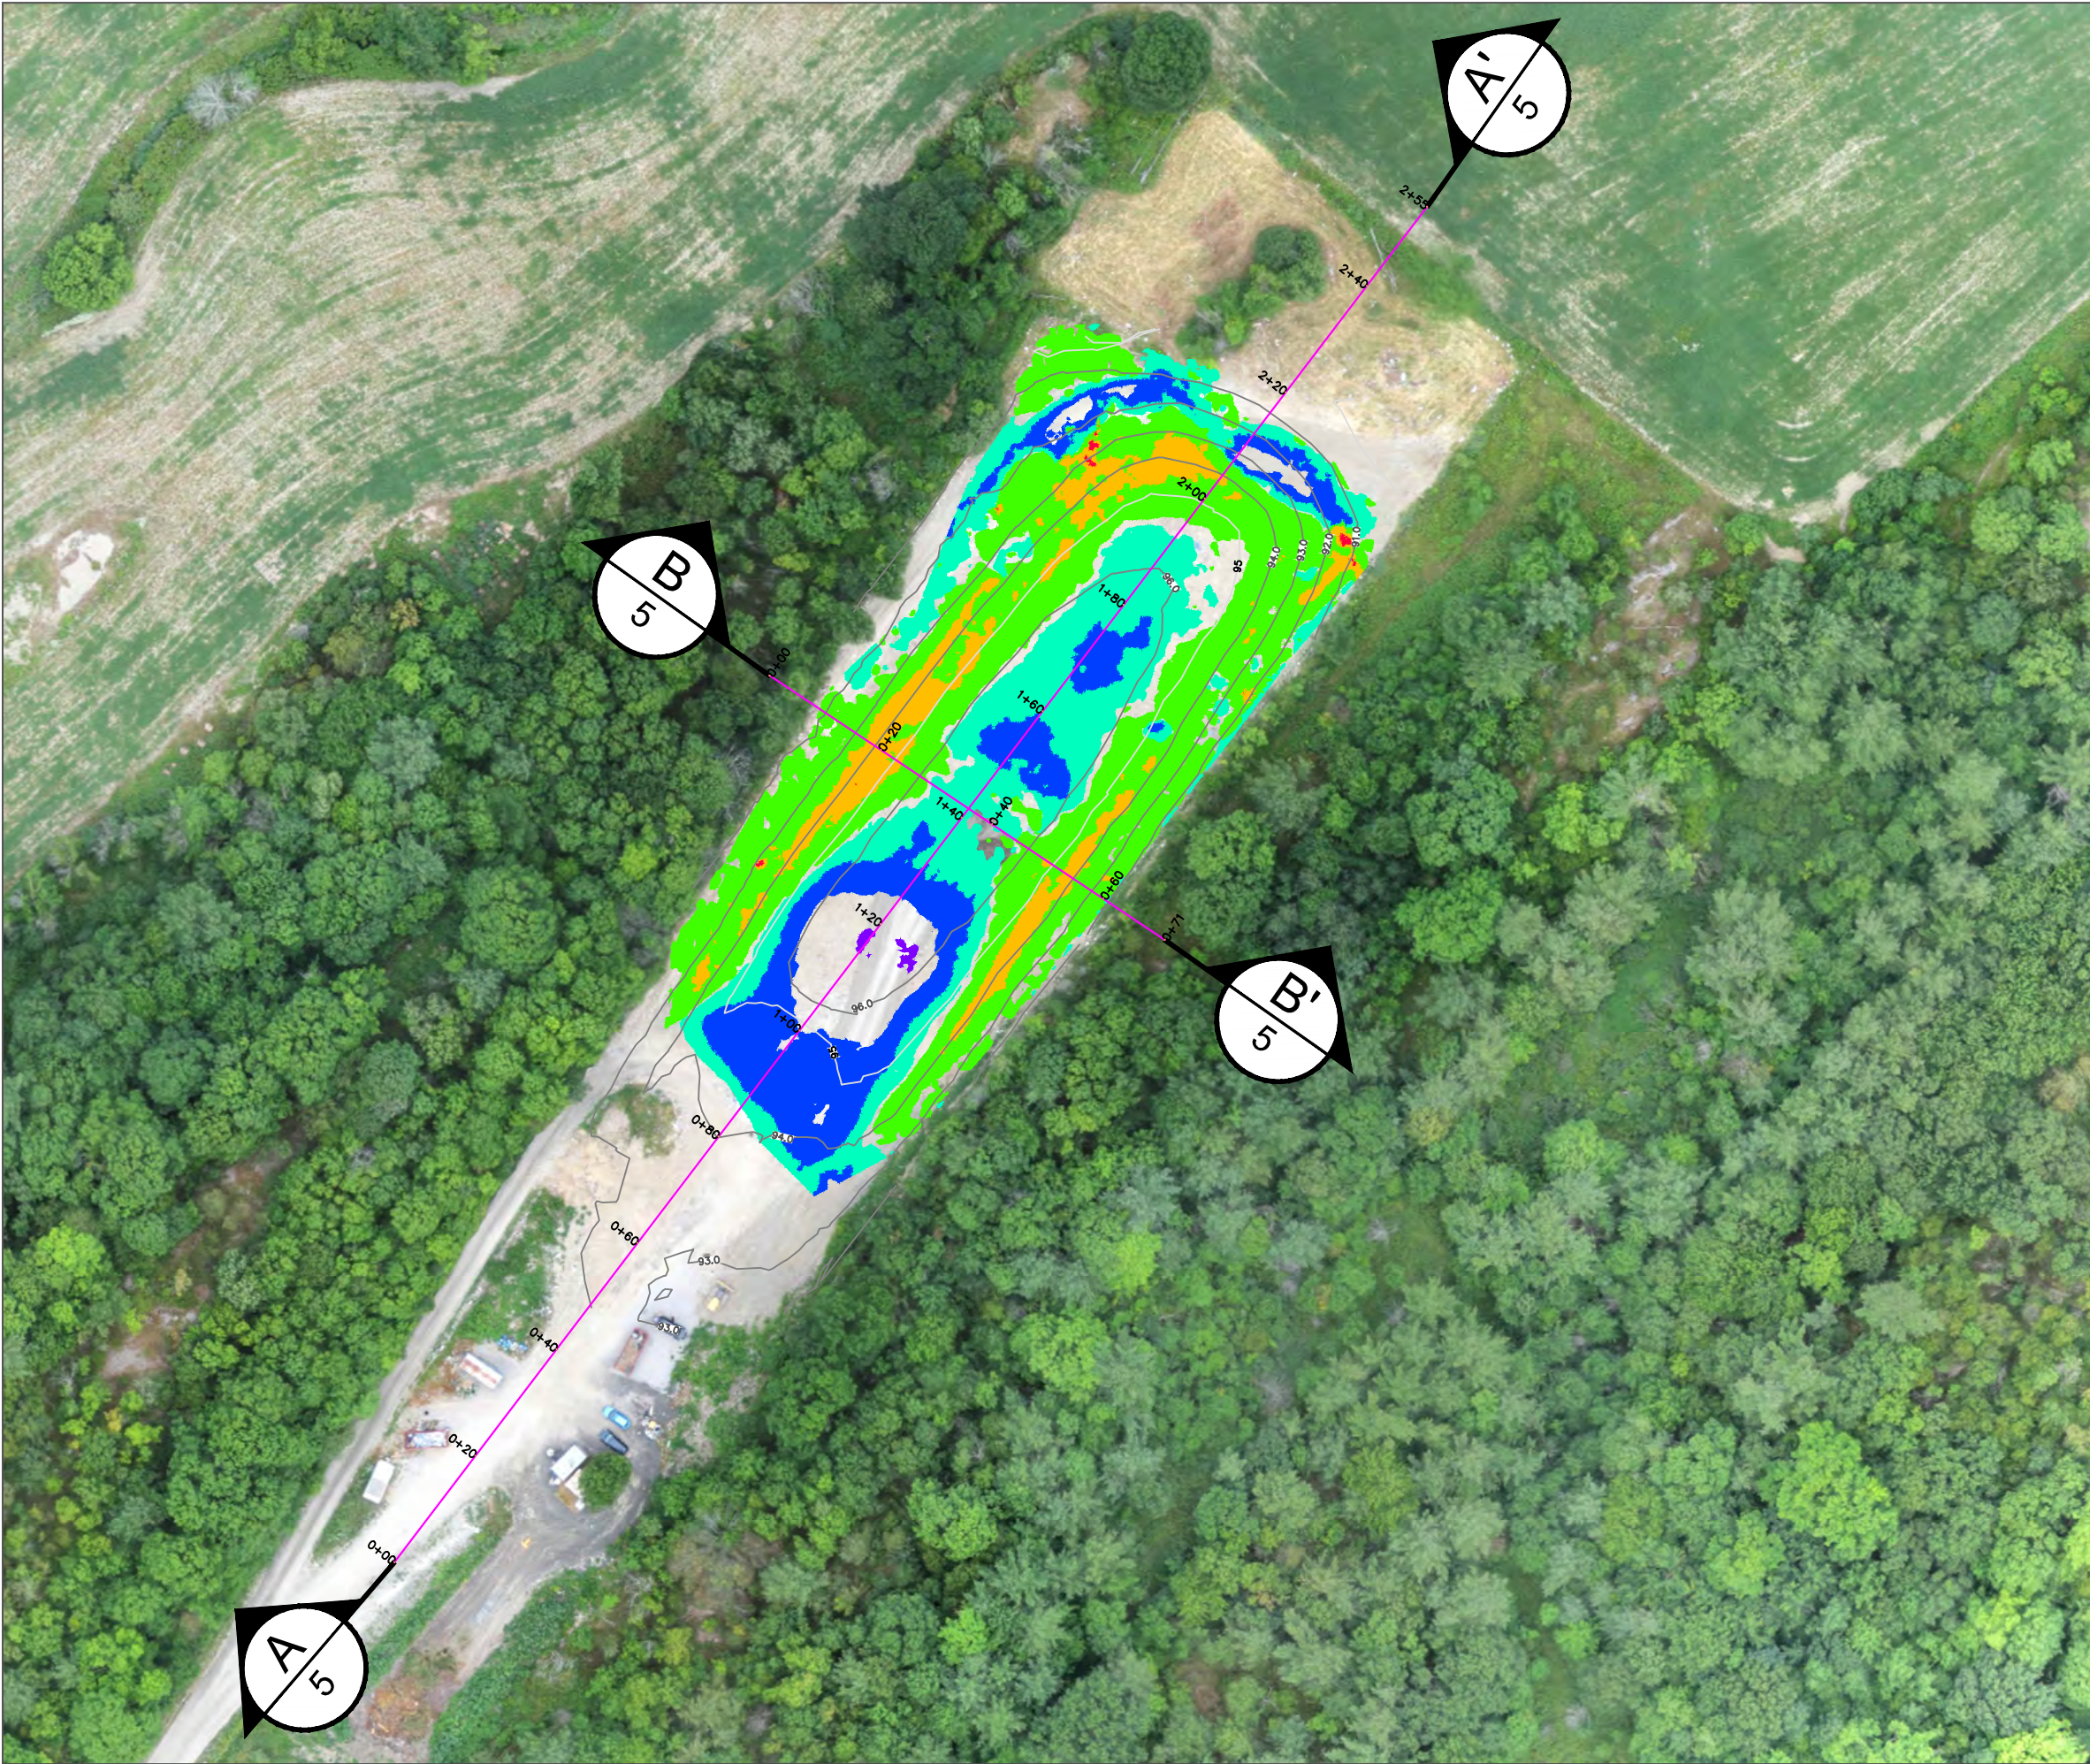
EXISTING GROUND (SURVEYED ON JULY 28, 2016)
