## MEMORANDUM

Subject: 2015-2016 Groundwater Assessment Report  
La Rue Mills WDS, Township of Leeds and the Thousand Islands

La Rue Mills Dump

Figure 1 – Groundwater Network

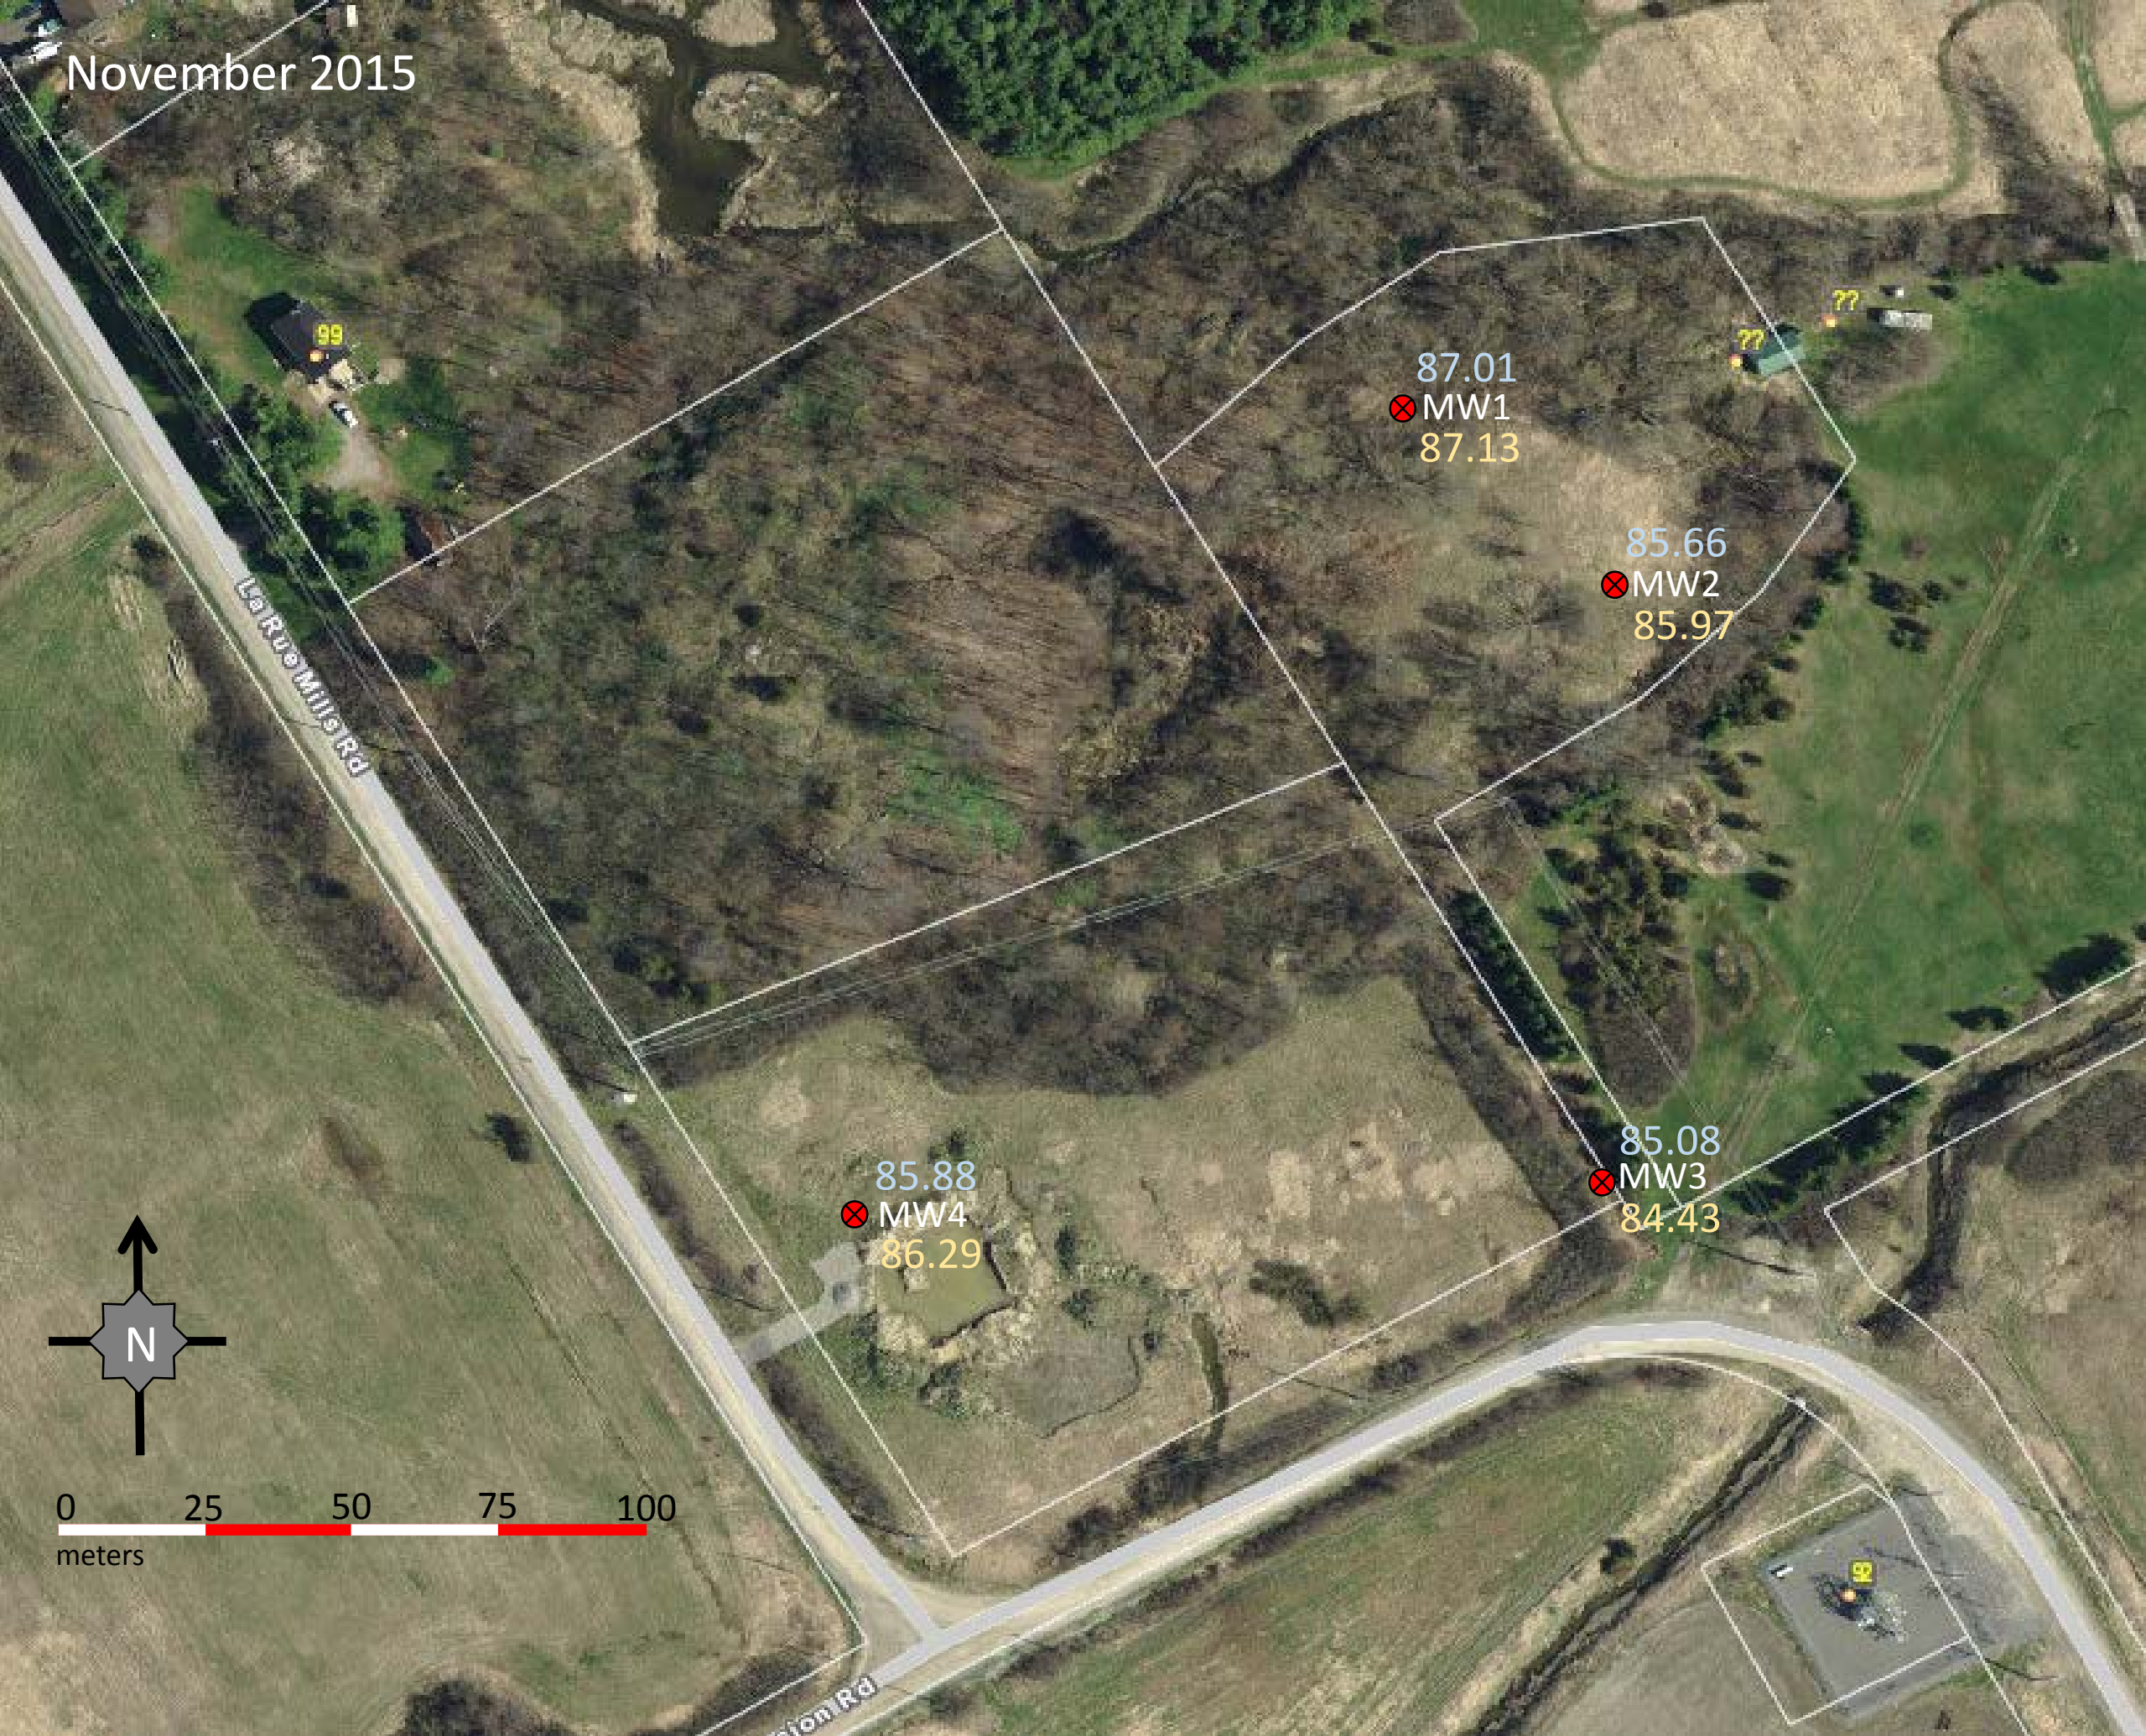
Four groundwater wells were sampled in the fall of 2015 and spring of 2016: MW1, MW2, MW3 and MW4. The location of these wells are presented in Figure 1. Groundwater elevations recorded by Andrew Day in 2015 (Figure 1) suggest that groundwater is flowing towards the southeast. The inference is made based on limited data, and lacks control points to the north, and east of the subject site. The Site is located on a topographic high, compared to the surrounding properties. It is possible that groundwater mounding and radial flow may be occurring.

Groundwater monitoring well

87.01 2-Nov-2015 GW elevation

87.13 30-Nov-2015 GW elevation

Background groundwater conditions have been based on results from MW1. Although potentially located near the waste fill area, MW1 appears to be up-gradient of the remaining wells and demonstrates the lowest concentrations of typical leachate indicators (Table 1).

Well MW2 is located in the southern portion of the waste fill area and shows elevated concentrations of the following typical leachate indicators: ammonia, DOC, conductivity, sulphate and boron. Concentrations of most of these parameters were lower in June 2016 compared to those reported in Nov 2015. The extent of impacts to the southeast of MW2 are unknown due to lack of wells.

Despite being located in the waste fill area, well MW1 shows little to no evidence of leachate. This implies that leachate impacts at MW2 are sourced somewhere between these two wells, suggesting that the northern boundary of the waste mound might be more southerly than depicted in Figure 2. However, without borehole logs and other Site details, it is difficult to determine whether this discrepancy can be attributed to geologic factors (for instance screening in a different lithology or aquifer than MW2).

Compared to background concentrations, MW3 showed elevated sulphate and boron, conductivity and ammonia. However, MW3 showed much lower concentrations of typical leachate parameters when compared to leachate well MW2.

Monitoring well MW4 showed elevated concentrations of the leachate indicator conductivity; however other leachate indicators (ammonia, DOC, sulphate, and boron) were consistent with

background concentrations. Monitoring well MW4 is located off-gradient from the leachate well (MW2). Based on the limited data available, it is unlikely leachate is impacting MW4.

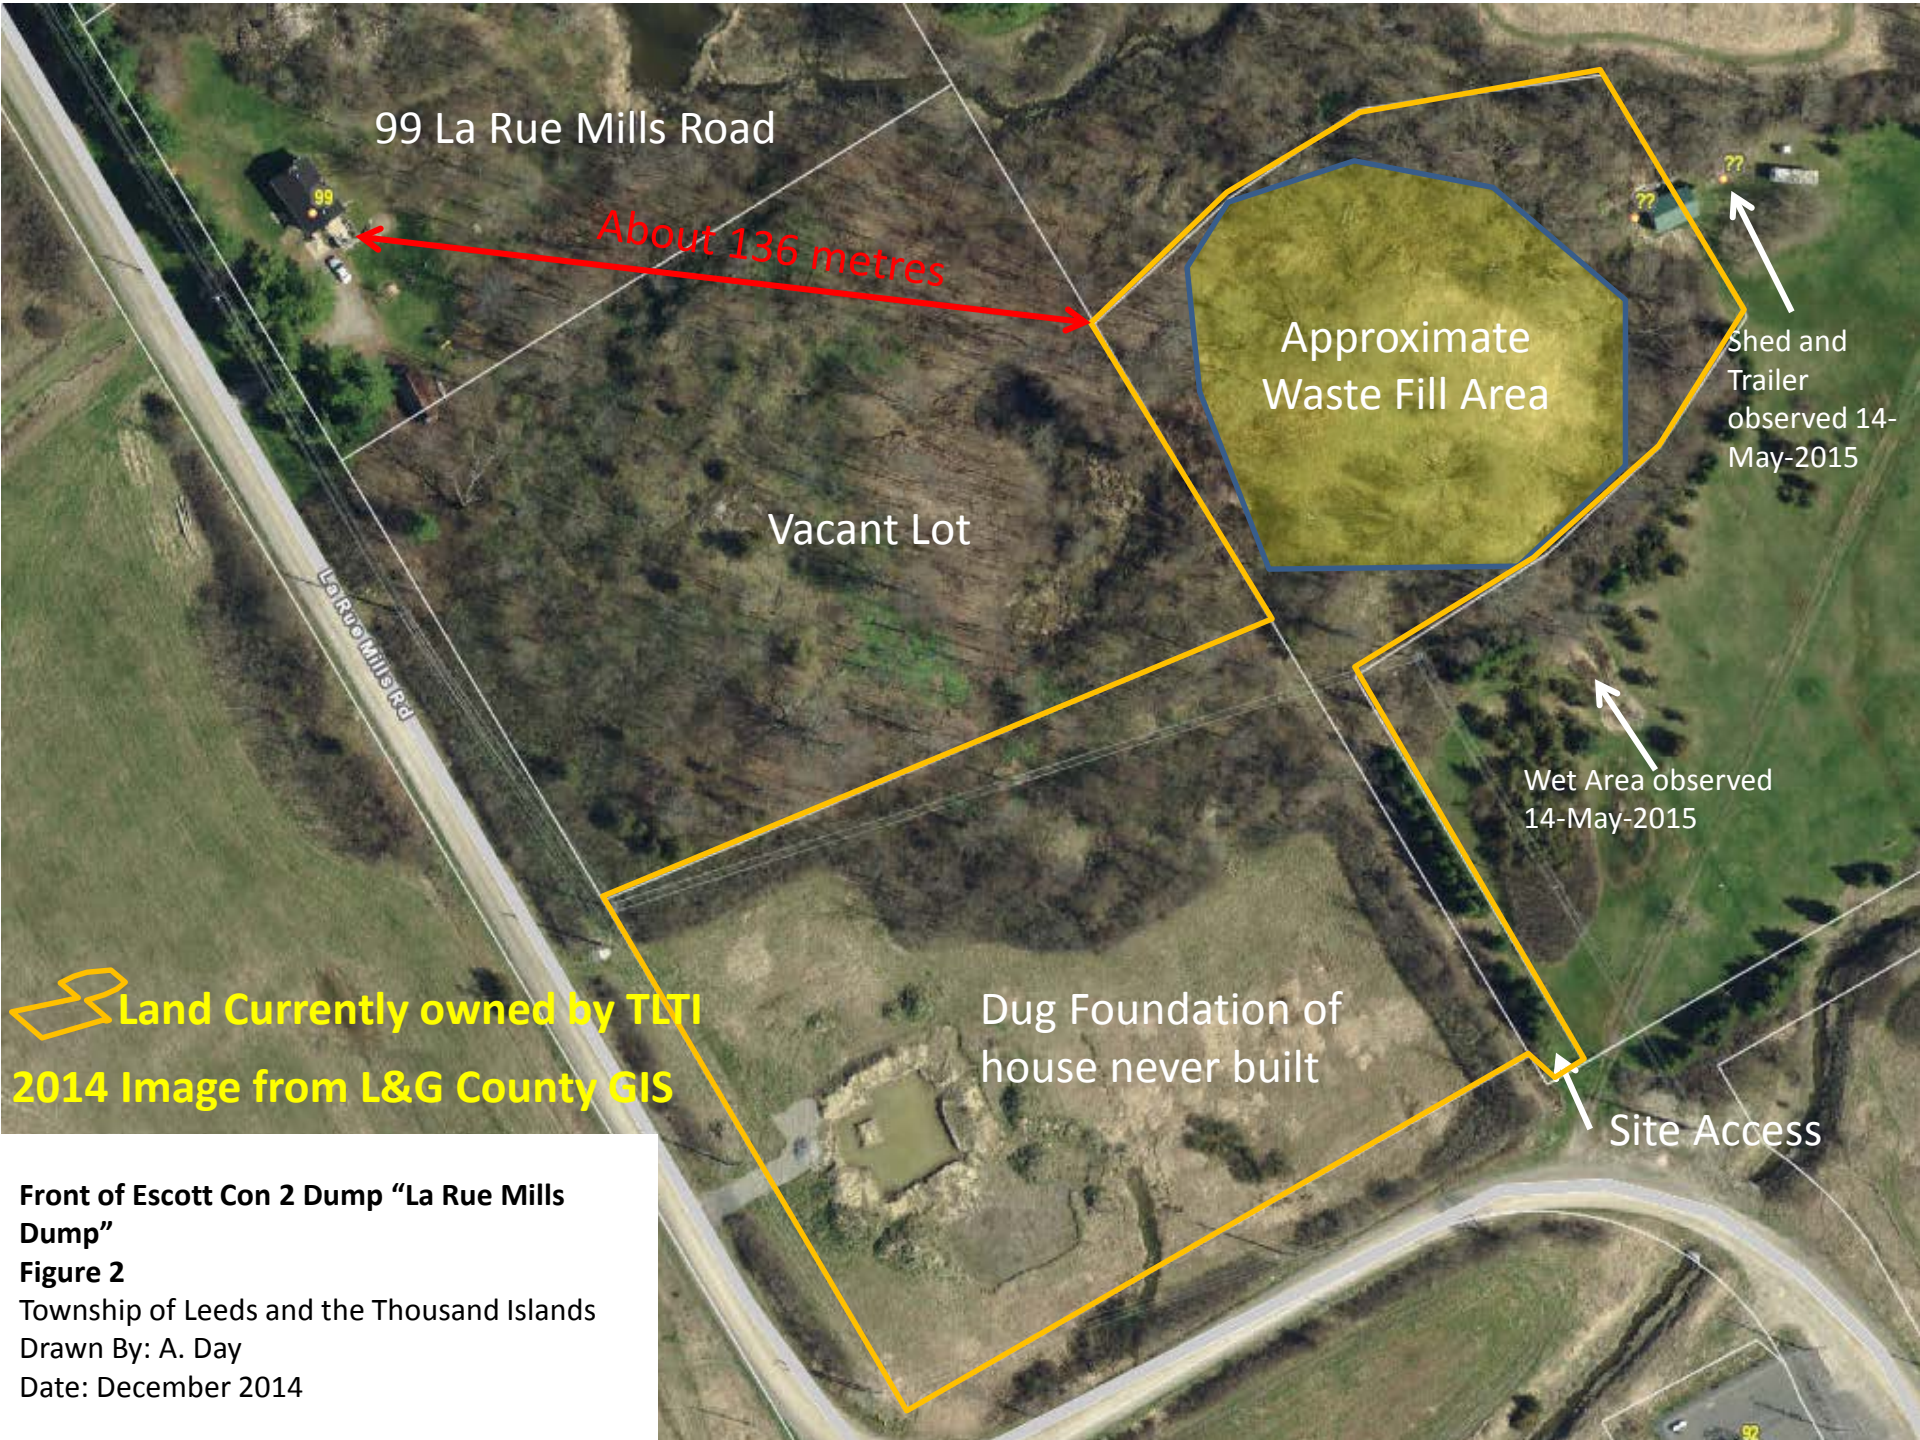
Figure 2

La Rue Mills WDS is surrounded by agricultural fields, forest and wetlands. Two cabins are located on the property to the east of the subject site, and a house is located to the north west of the Site at 99 La Rue Mills Road. The monitoring network is shown in Figure 1. The property boundary and extent of the waste fill area are depicted in Figure 2.

Approximate  
Waste Fill Area

Shed and  
Trailer  
observed 14-  
May-2015

Wet Area observed  
14-May-2015

Dug Foundation of  
house never built

Front of Escott Con 2 Dump "La Rue Mills  
Dump"
