July 30, 2025
File: 1645.00-102

Subject: Hydrogeological Evaluation Update for Part of Lots 19 & 20
Concession 1, Leeds and the Thousand Islands, Ontario

R0	2024-06-07	issued in final	ZL	JMP
Rev	Date	Description	By	Chkd
Site Plan				
Hydrogeological Evaluation Part of Lots 19 & 20 Concession 1, Leeds and the Thousand Islands, ON				
File: 1645.00-102		Figure 1

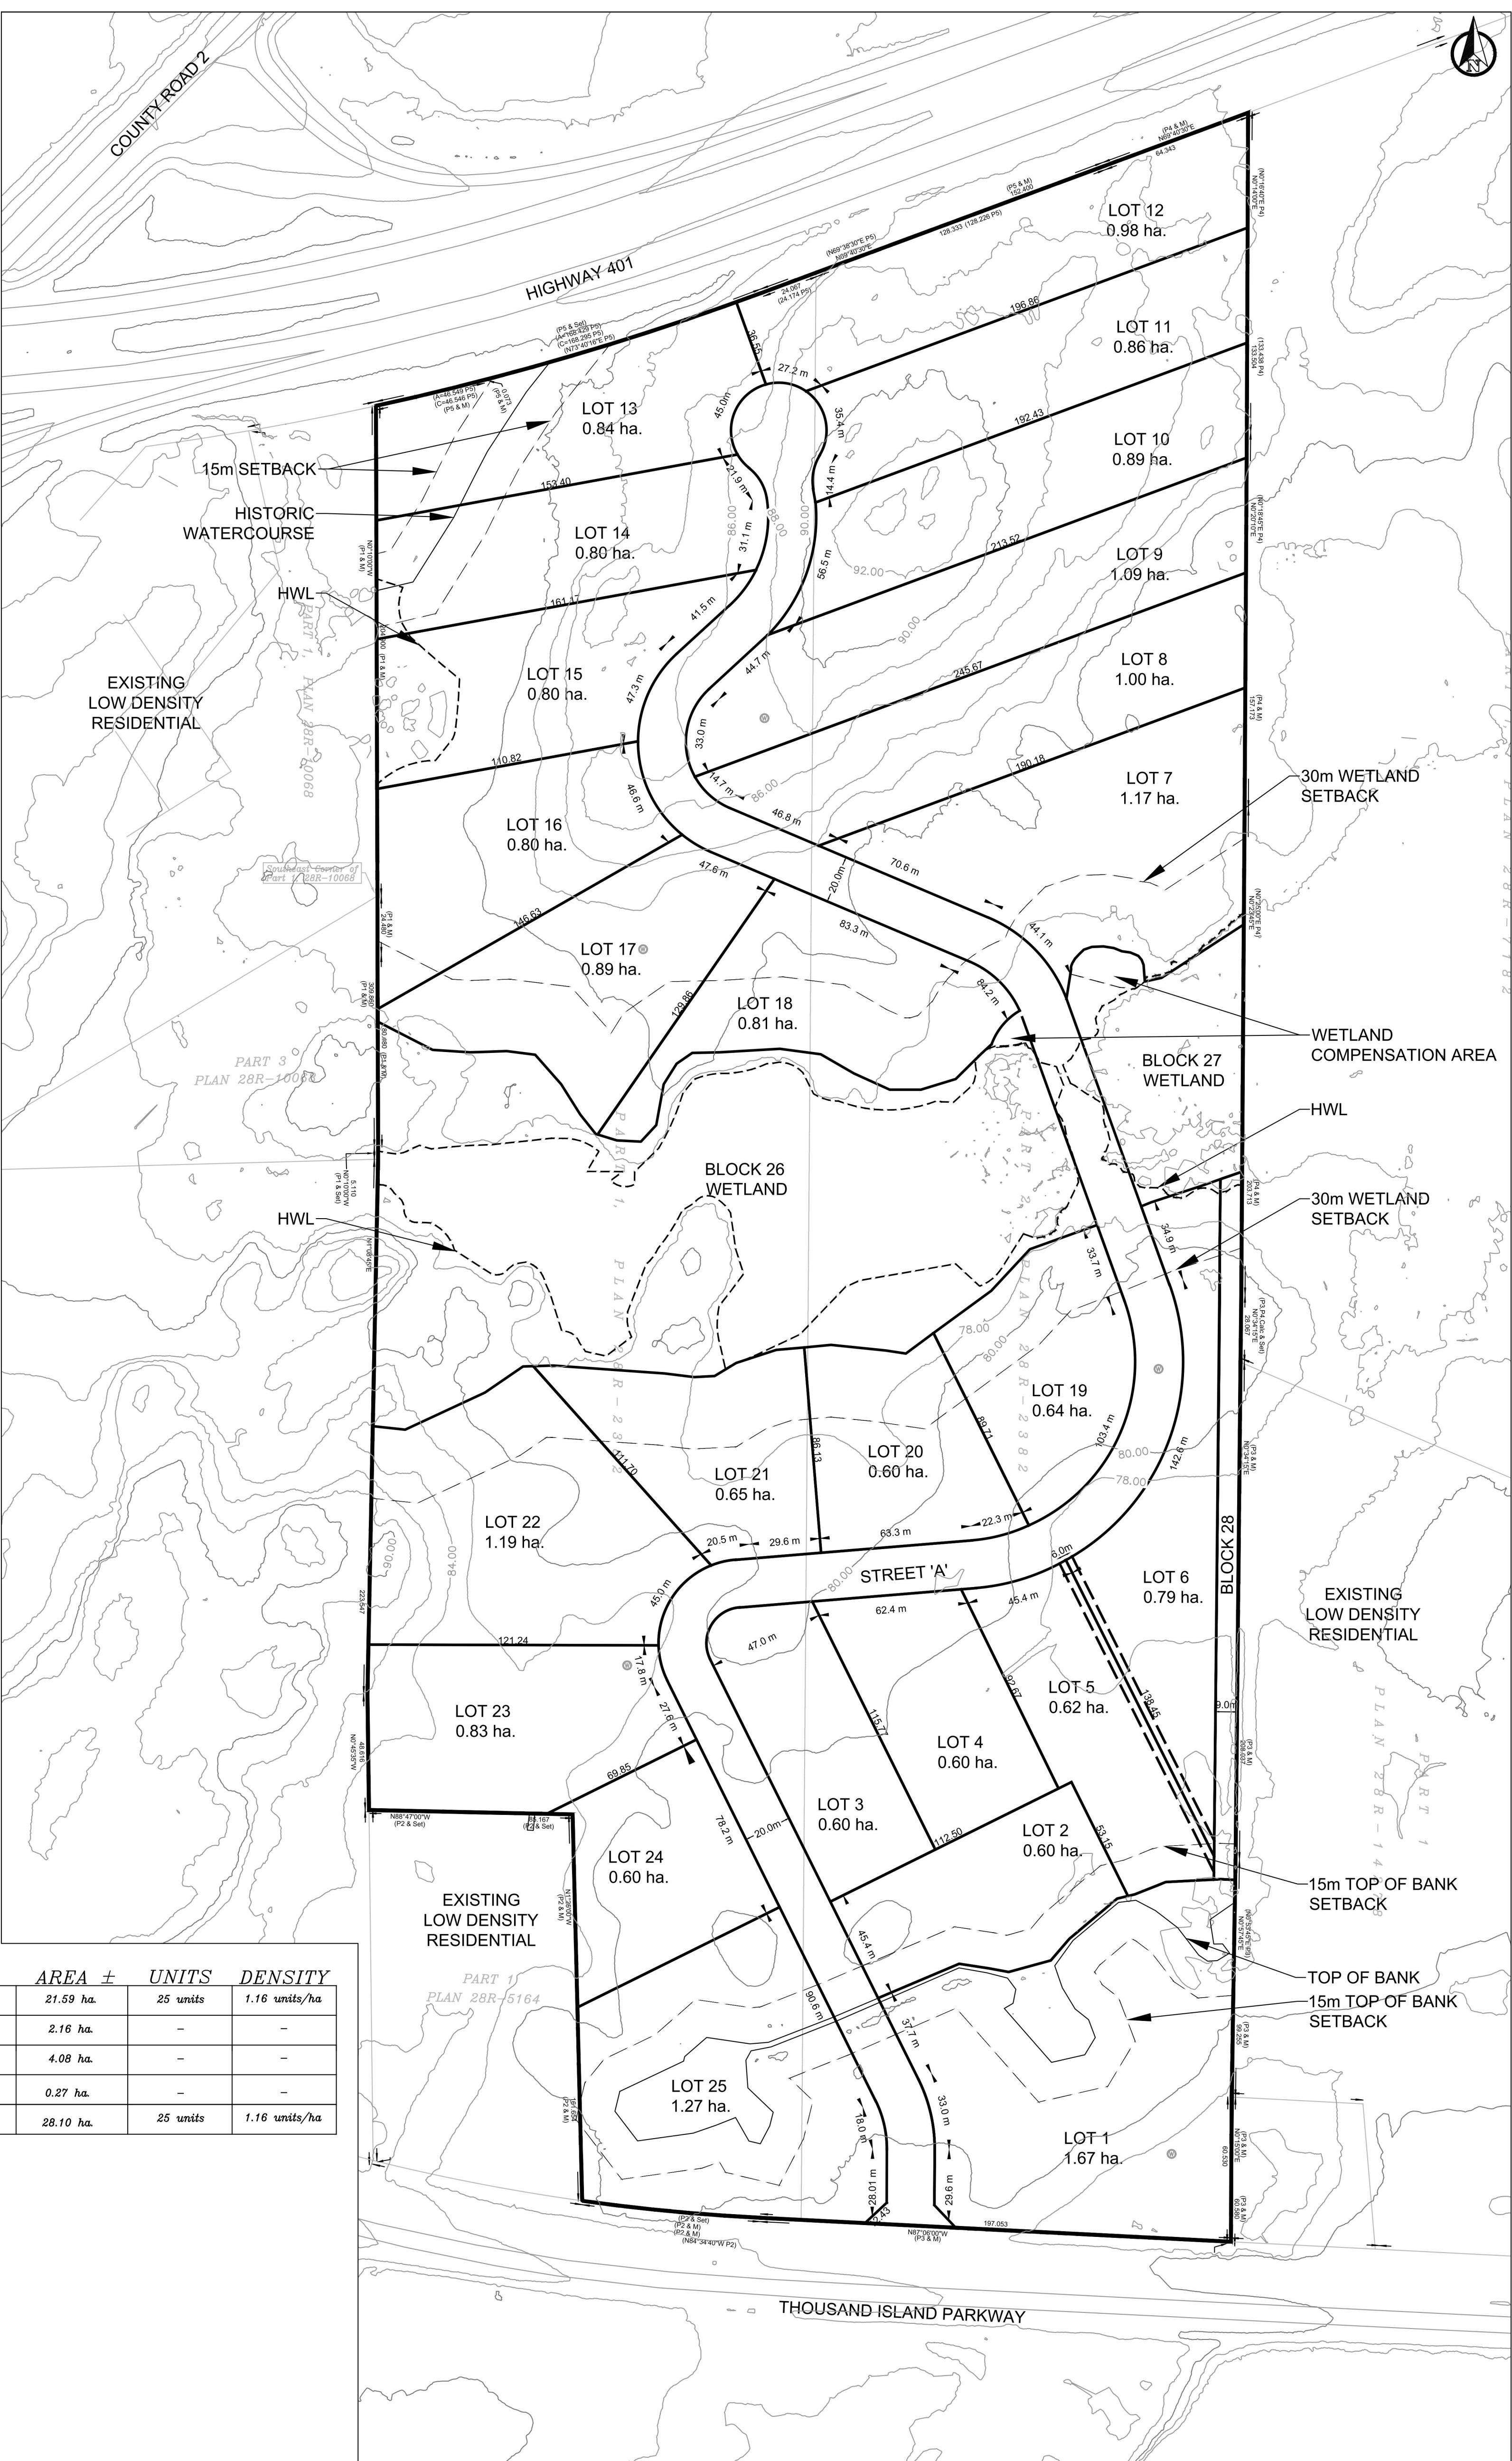
DRAFT PLAN of PROPOSED SUBDIVISION

PART OF LOTS 19 & 20, CONCESSION 1

LAND USE	LOTS & BLOCKS	AREA ±	UNITS	DENSITY
SINGLE DETACHED	LOTS 1-25	21.59 ha.	25 units	1.16 units/ha
STREETS/RESERVES	STREET 'A'	2.16 ha.	—	—
WETLAND	BLOCK 26, BLOCK 27	4.08 ha.	—	—
AREA COMPENSATION	BLOCK 28	0.27 ha.	—	—
TOTAL		28.10 ha.	25 units	1.16 units/ha

The subject site is located on Parts of Lots 19 and 20, Concession 1 in the township of Leeds and the Thousand Islands. The subject site is bounded by Highway 401 to the north and the Thousand Islands Parkway to the south. The proposed plan includes the subdivision of the subject site into 25 single family lots as shown on the attached Draft Plan of Subdivision and Figure 1.

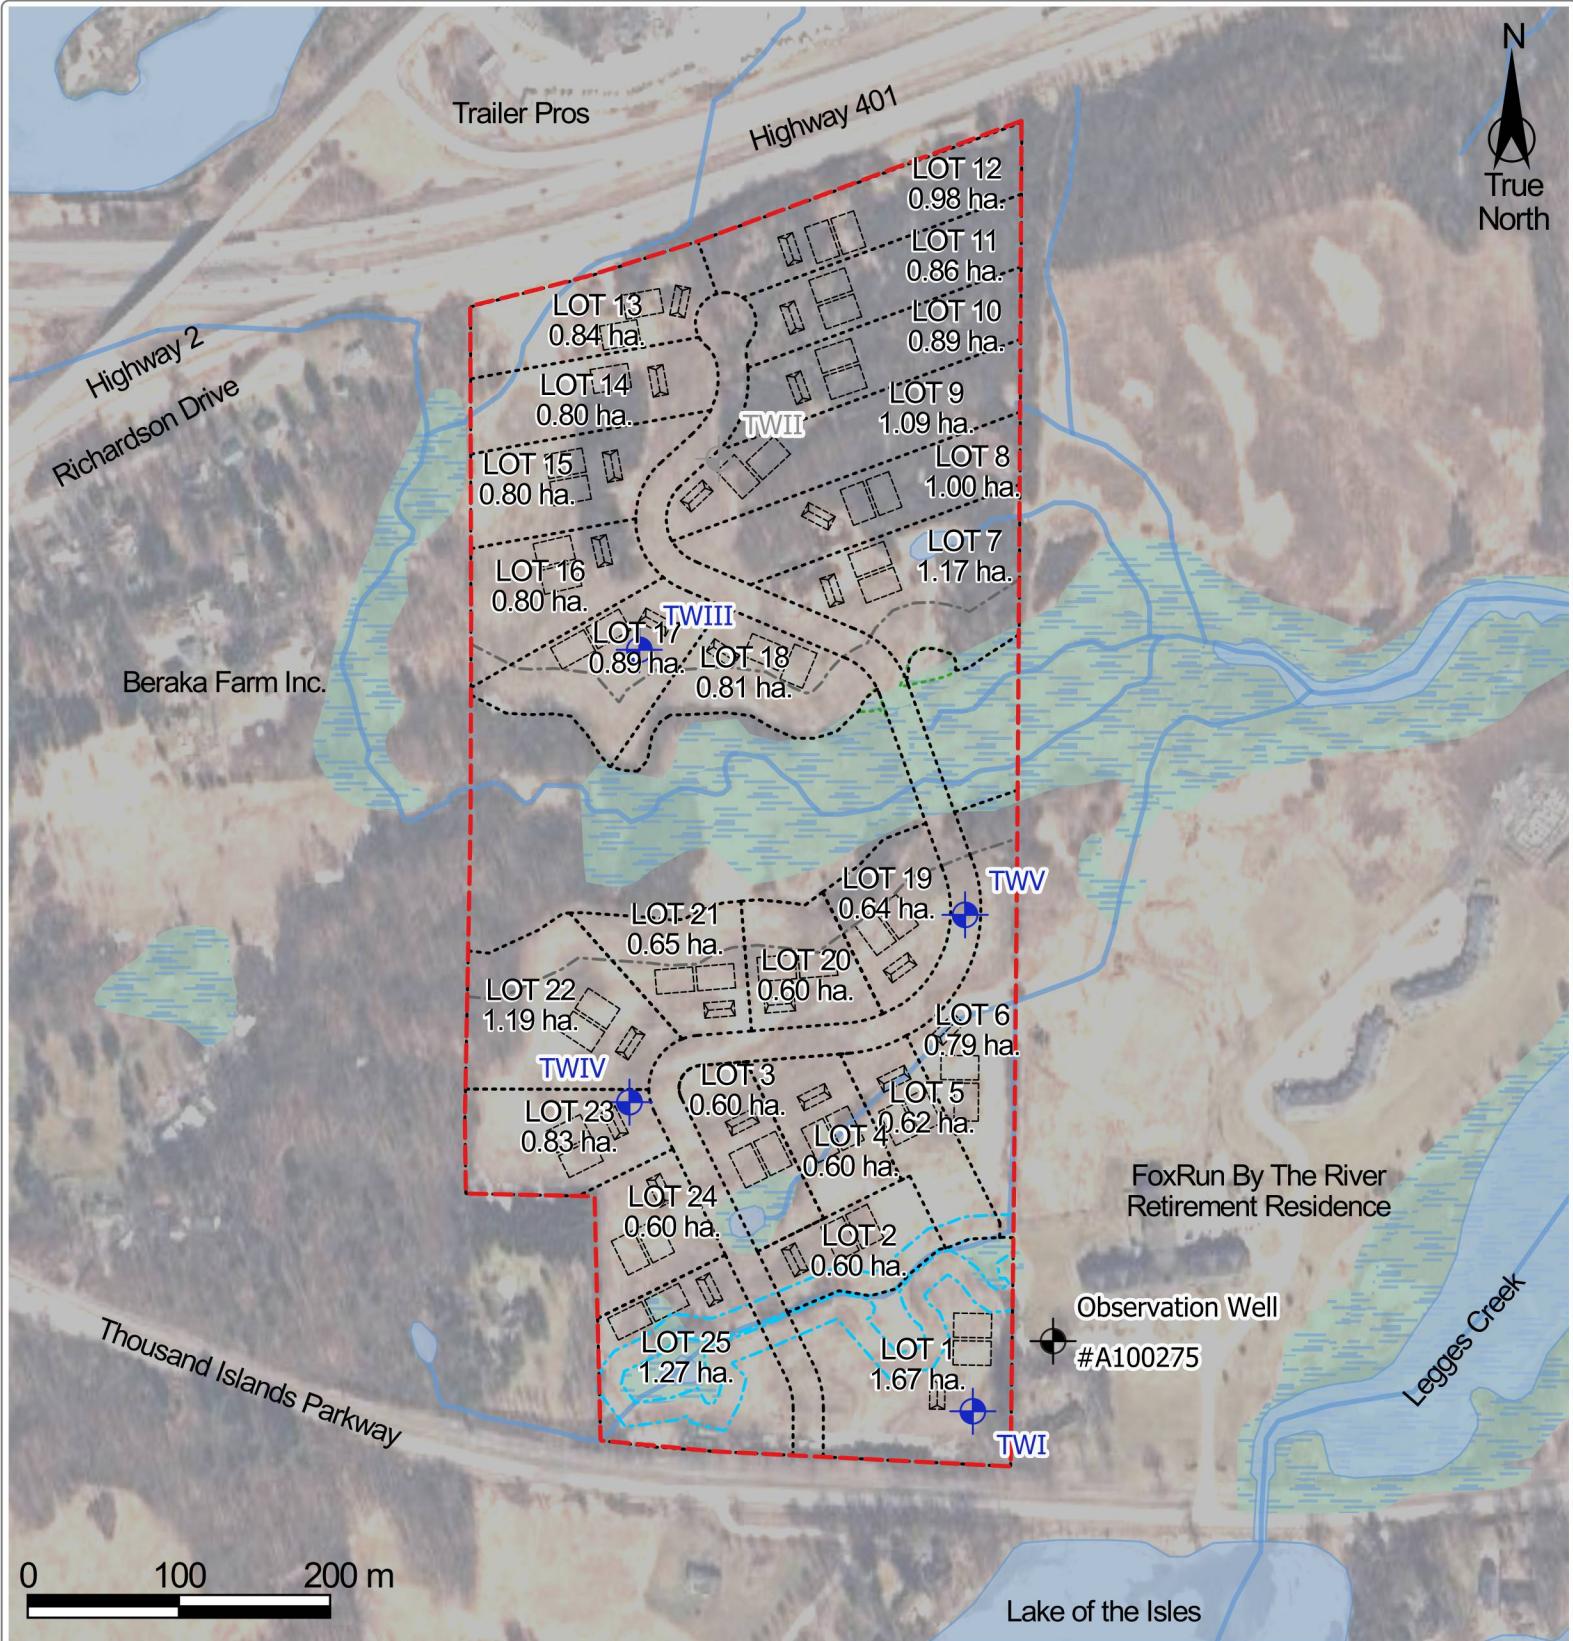
- approximate subject site boundary
- wetlands
- surface water body
- surface water course
- proposed lots with houses
- proposed drainage features
- proposed creek offsets
- proposed wetlands
- approximate location of test wells
- approximate location of observation well
- approximate location of damaged test well not included in testing program

The test well and observation well locations were surveyed using a Trimble R10 Global Navigation Satellite System device (Trimble GNSS). The locations of the test wells and observation well are indicated on Figure 1.

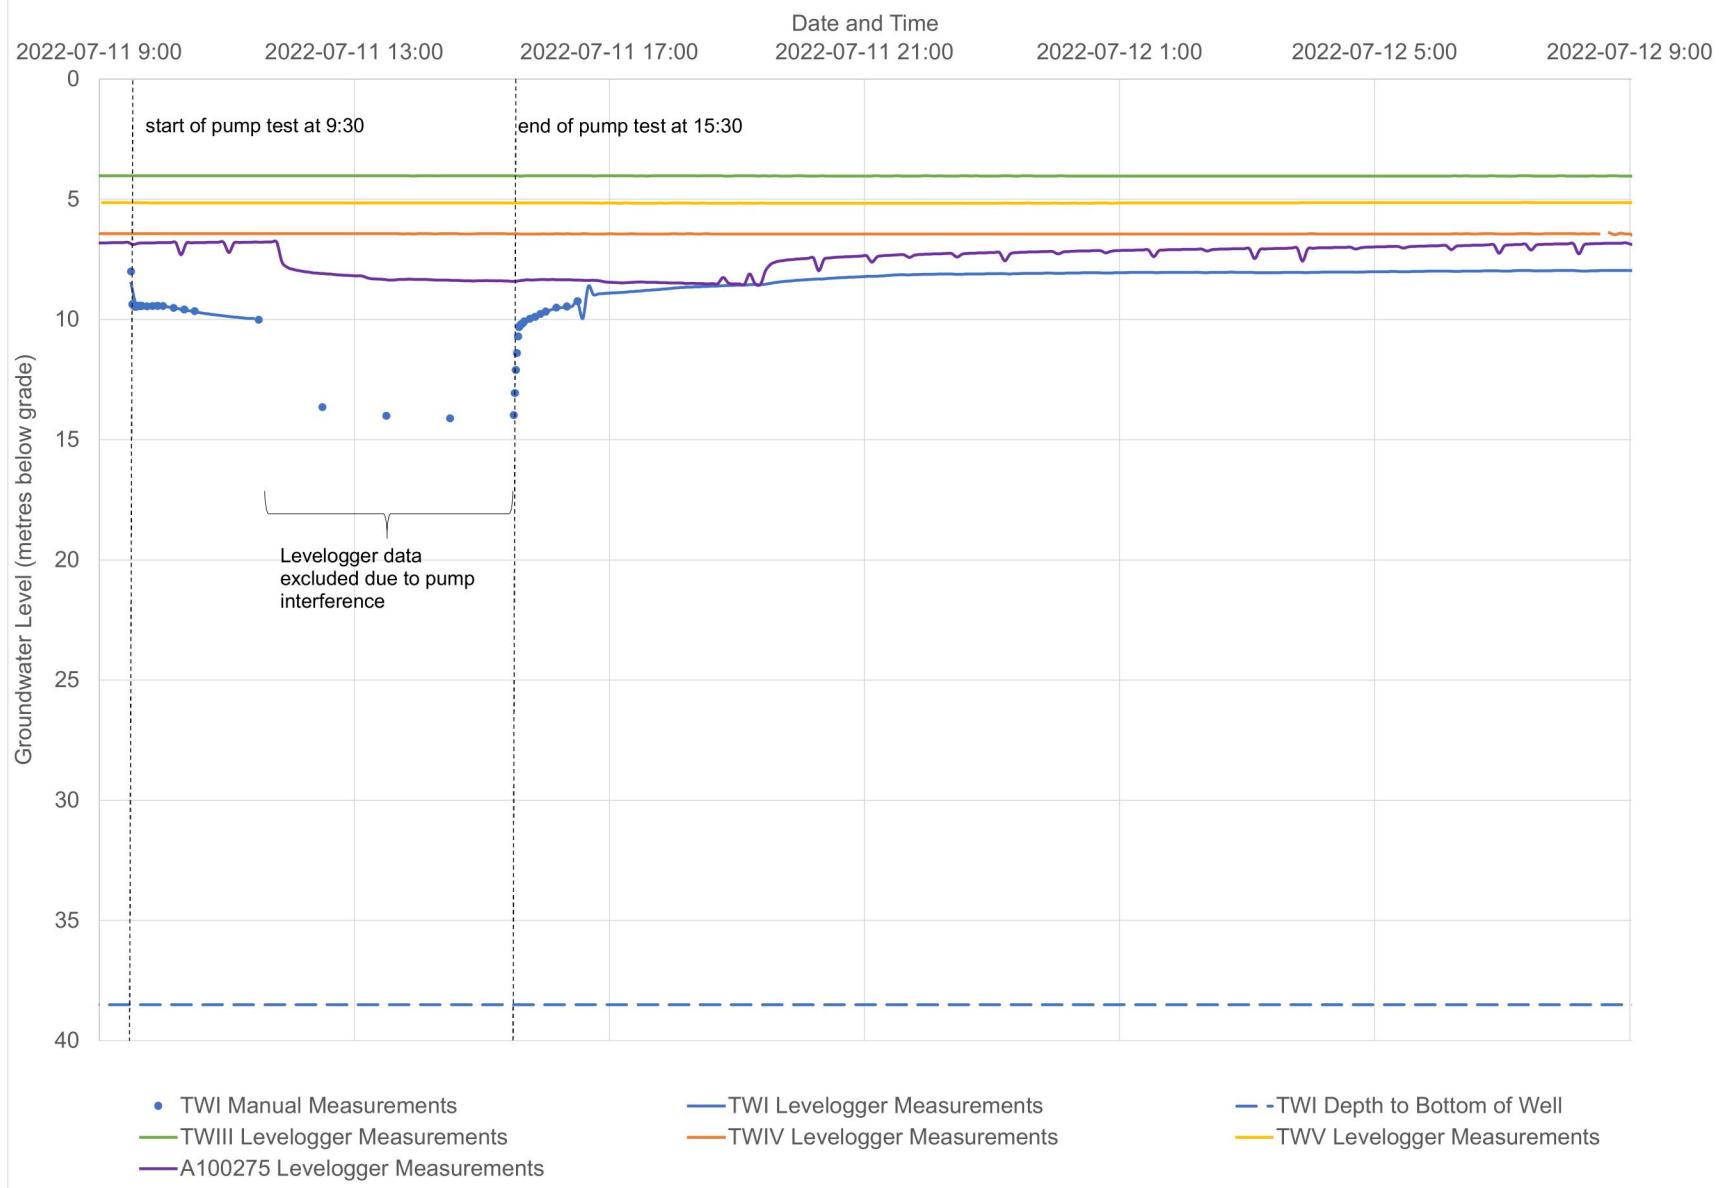
Figure 2a
Pump Test TWI - Water Level vs Time

- The first pumping test was conducted on TWI on July 11, 2022. A maximum drawdown of approximately 6.1 m (to a depth of approximately 14.6 metres below the top of the well casing (mbTOC) was observed and approximately 24.4 meters of water remained in the well at the completion of the pumping test. TWI returned to 95% of the initial water level, within approximately 4 hours and 55 minutes after the completion of the pumping test.

During the 6-hour pumping tests performed at TWI, TWIII, TWIV, and TWV, the water levels in the test wells and the observation well (#A100275) located at Fox Run by the River Retirement Residence were monitored through the use of level loggers. A Review of the data indicates that during the pumping tests only the pumping well exhibited drawdown related to pumping (see Figures 2a to 2d, attached).

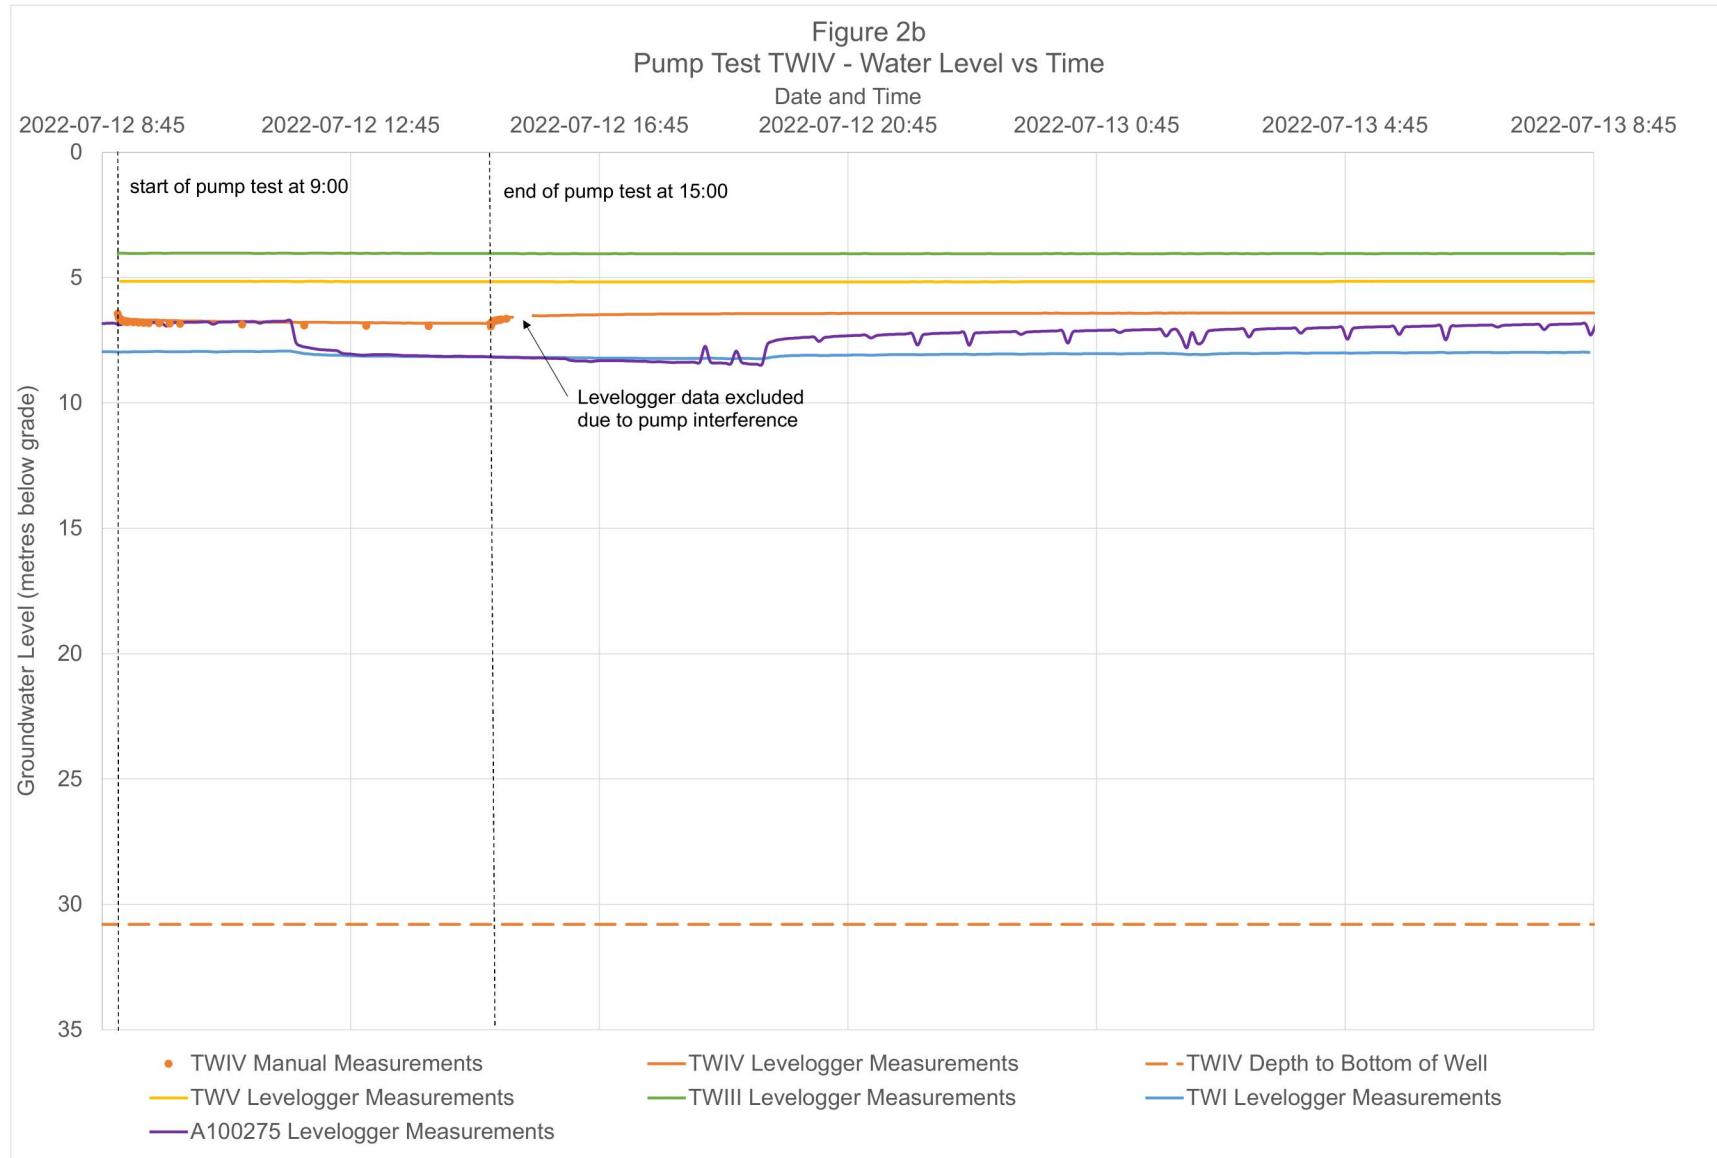
- The second pumping test was conducted on TWIV on July 12, 2022. A maximum drawdown of approximately 0.5 m (to a depth of approximately 7.4 mbTOC) was observed and approximately 23.9 meters of water remained in the well at the completion of the pumping test. TWIV returned to 95% of the initial water level, within approximately 2 hours after the completion of the pumping test.

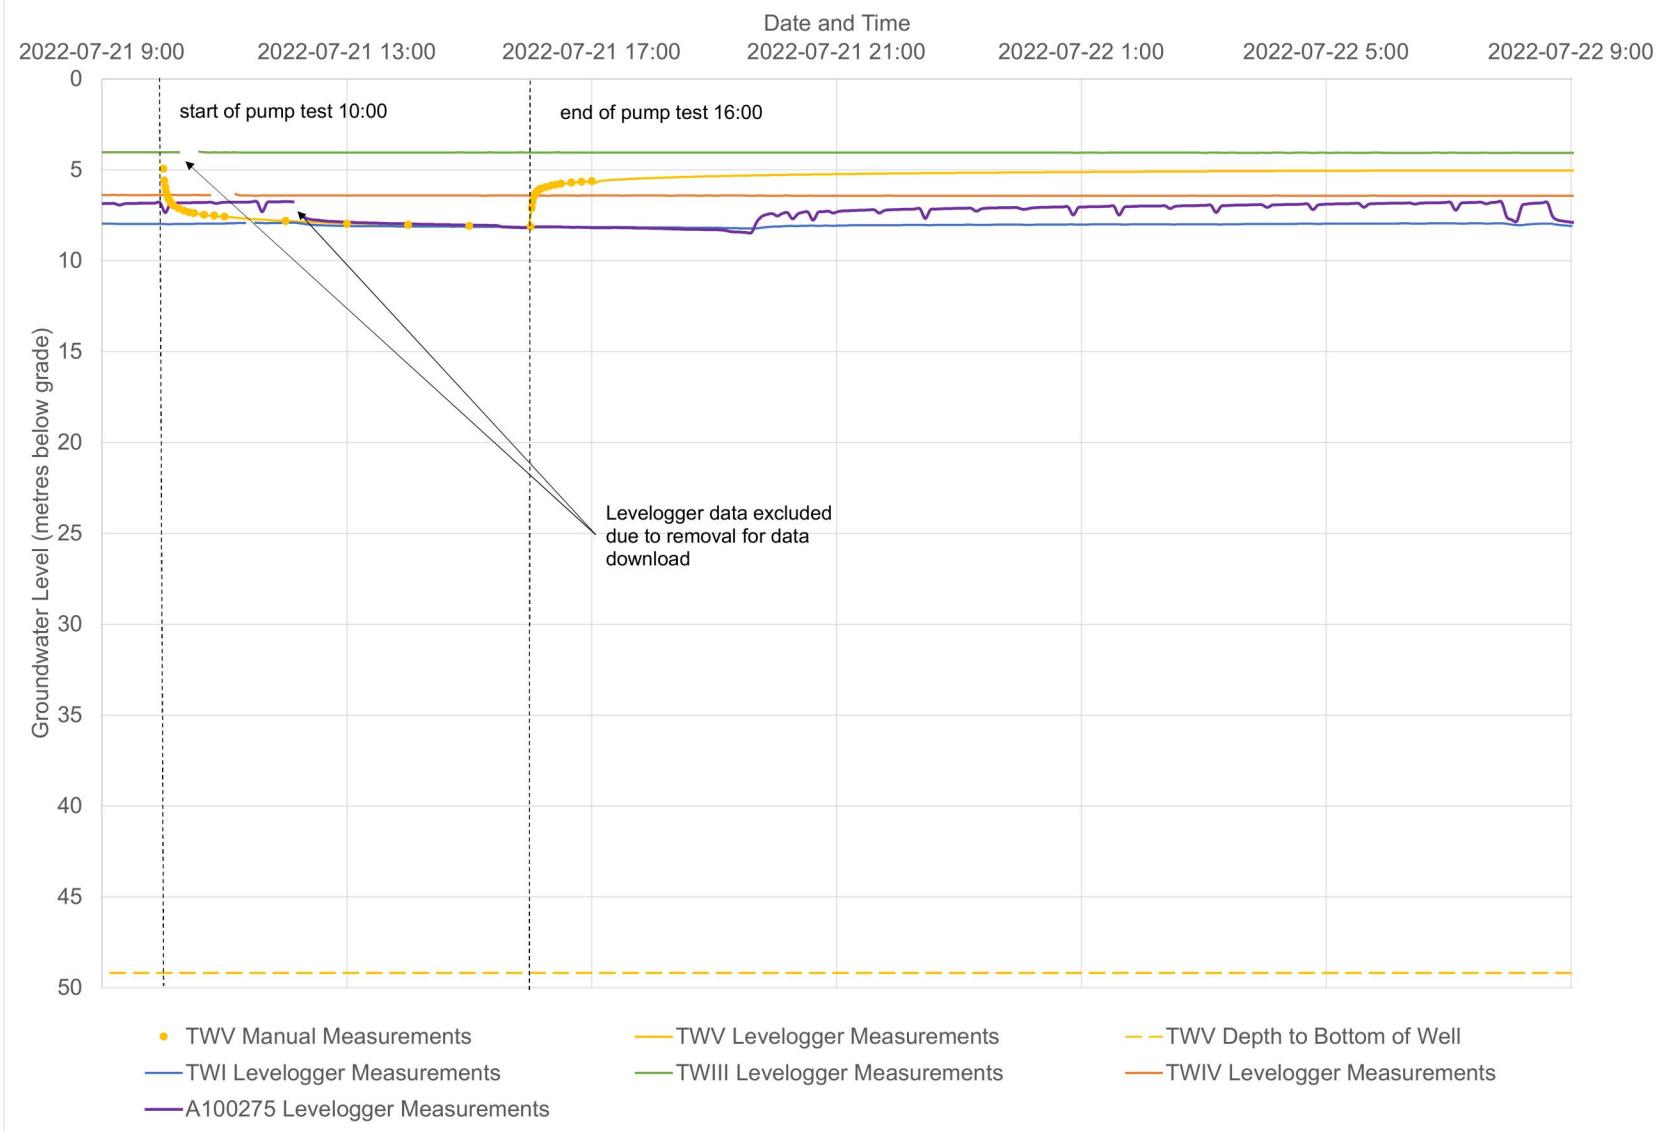
Figure 2c
Pump Test TWV - Water Level vs Time

- The third pumping test was conducted on TWV on July 21, 2022. A maximum drawdown of approximately 3.2 m (to a depth of approximately 8.6 mbTOC) was observed and approximately 41.1 meters of water remained in the well at the completion of the pumping test. TWV returned to 95% of the initial water level, within approximately 9 hours and 53 minutes after the completion of the pumping test.

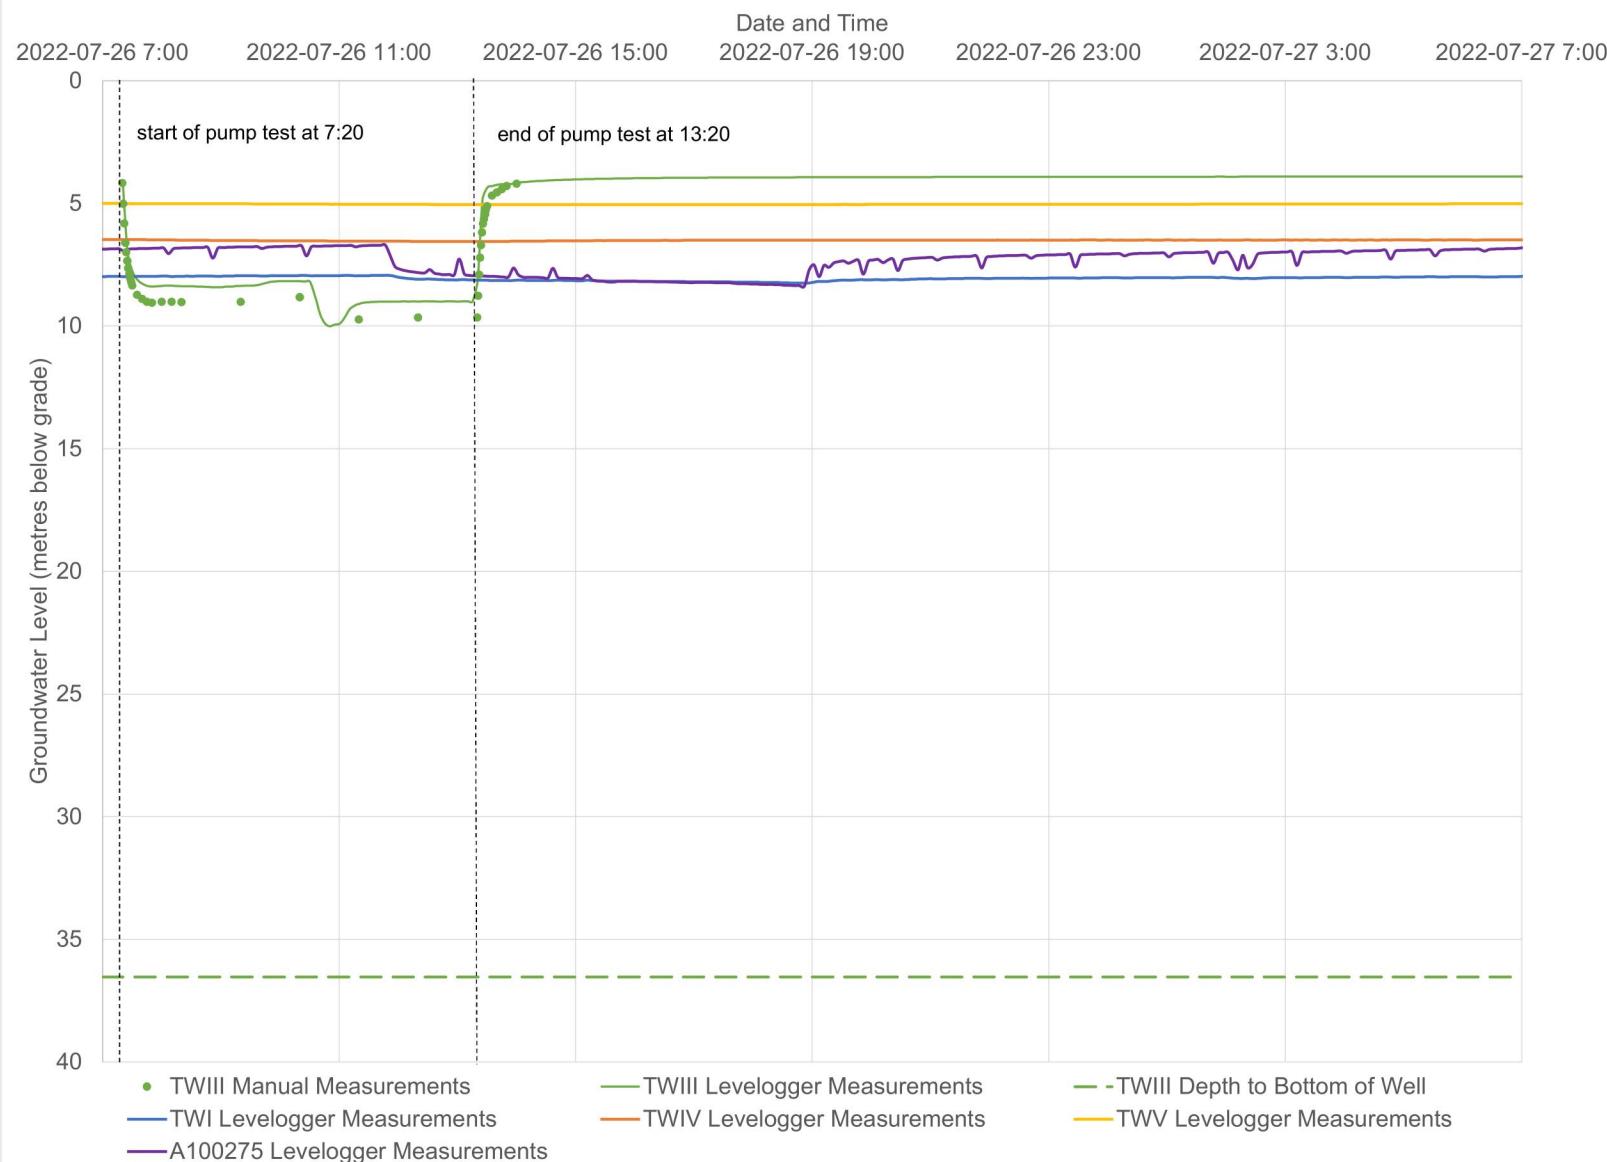
Figure 2d
Pump Test TWIII - Water Level vs Time

- The fourth pumping test was conducted on TWIII on July 26, 2022. A maximum drawdown of approximately 5.6 m (to a depth of approximately 10.1 mbTOC) was observed and approximately 26.8 meters of water remained in the well at the completion of the pumping test. TWV returned to 95% of the initial water level, within approximately 10 minutes after the completion of the pumping test.

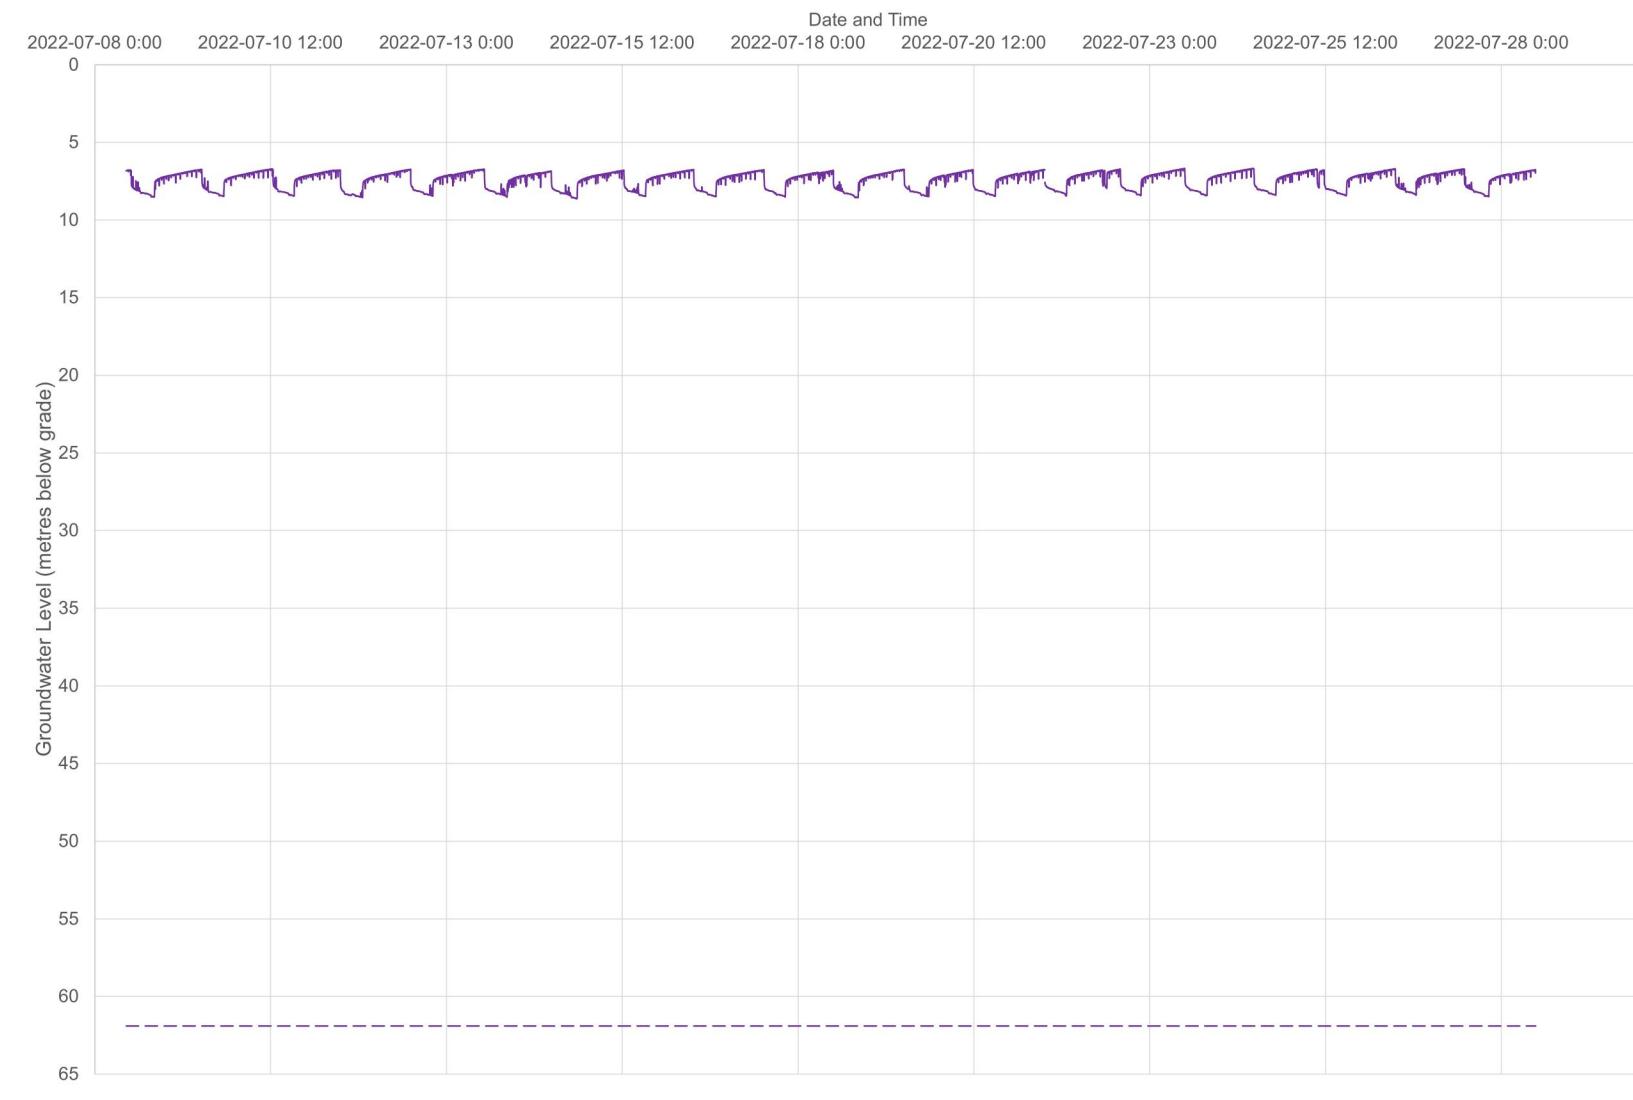
Figure 3
Observation Well (#A100275) - Water Level vs Time

Water level data collected from the observation well (#A100275) for the period of July 8 to 28, 2022 indicates a trend showing drawdown and recovery over an approximate 24-hour cycle. Observed drawdown in this well appears to be associated with water usage by the occupants of the Fox Run by the River Retirement Residence (see Figure 3, attached). Pumping tests conducted at the four test wells does not appear to contribute to the drawdown observed at the off-site observation well.

During the 6-hour pumping tests conducted at TWI, TWIII, TWIV, and TWV, level loggers were utilized to monitor the water levels in the test wells and the observation well (#A100275) located at Fox Run by the River Retirement Residence. Water level data collected from the observation well (#A100275) between July 8 and 28, 2022 indicates a trend of approximately 2 meters of drawdown per day followed by recovery over approximately 8 hours. The observed drawdown in this well seems to be associated with the water usage by the occupants of Fox Run by the River Retirement Residence (refer to Figure 3 attached).
